ROOF EVALUATIONS

Clarkstown Central
School District

June 2015

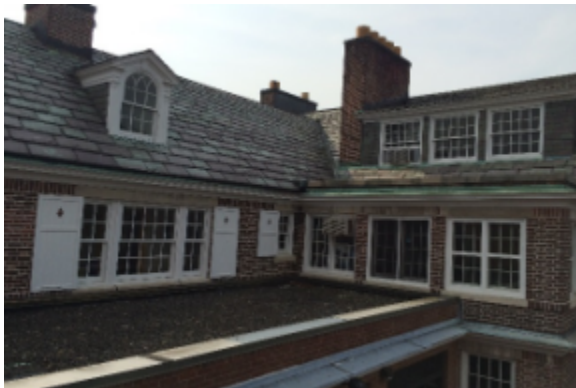
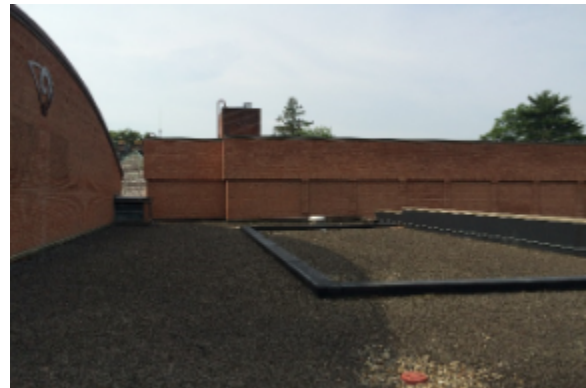
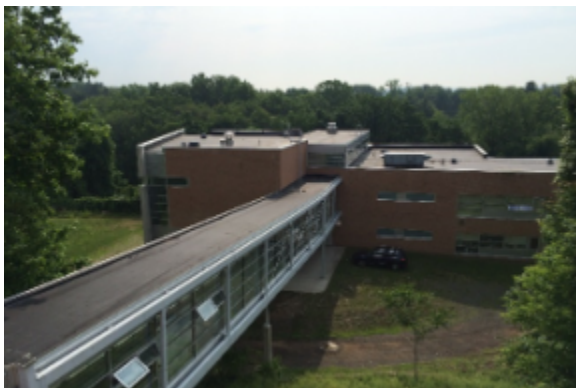
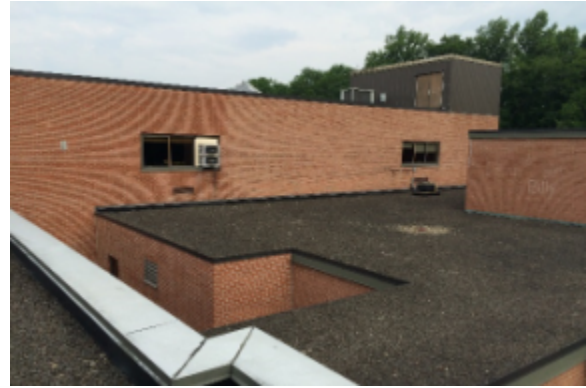
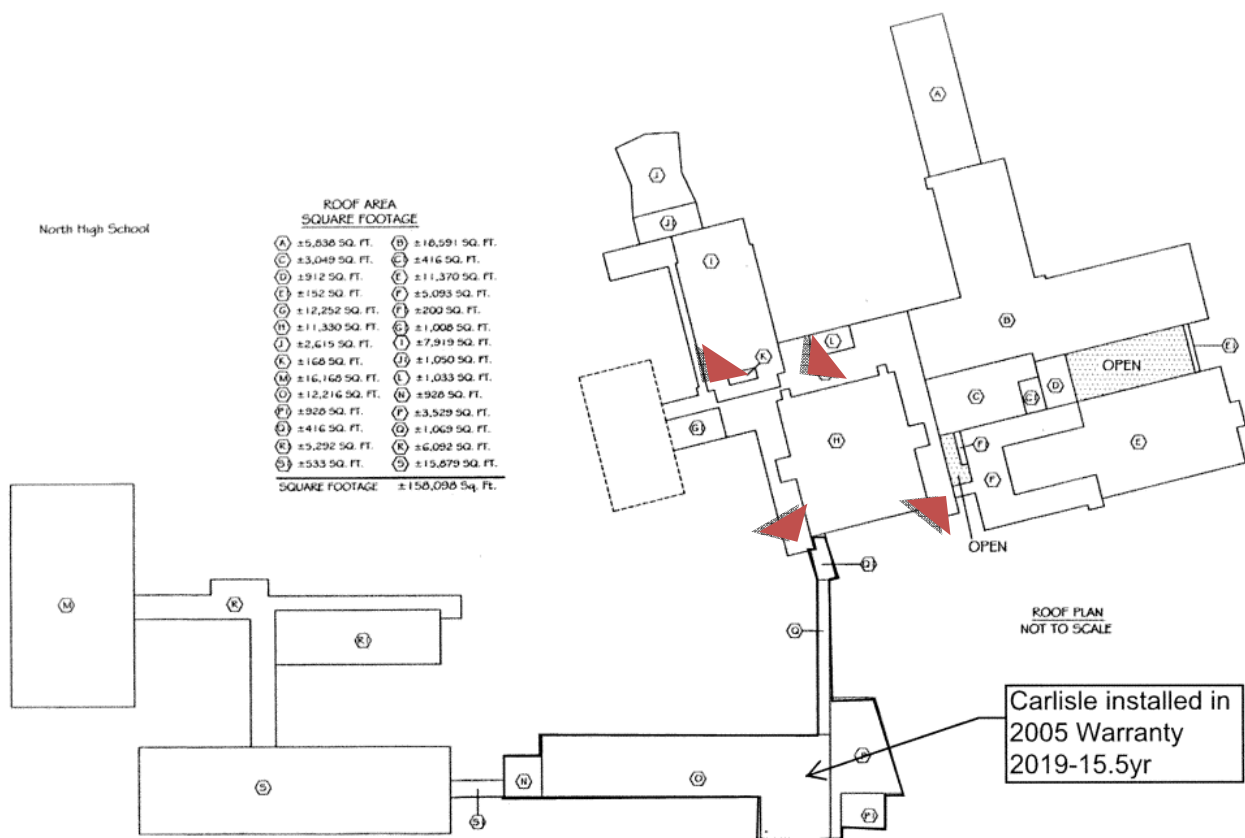
Clarkstown North HS**Description:**

- A. Original Vintage- Poor Condition (≈30 year old system).
- B. Main Addition- Poor Condition (≈30 year old system).
- C. Annex Addition- Fair to Poor Condition (≈30 year old system).
- D. Recent Addition- Good Condition (≈11 year old system).
- E. Multiple stepped conditions above lower roofs.
- F. Existing curb reveal requires additional investigation, newer curb penetrations, within IRMA system are acceptable.

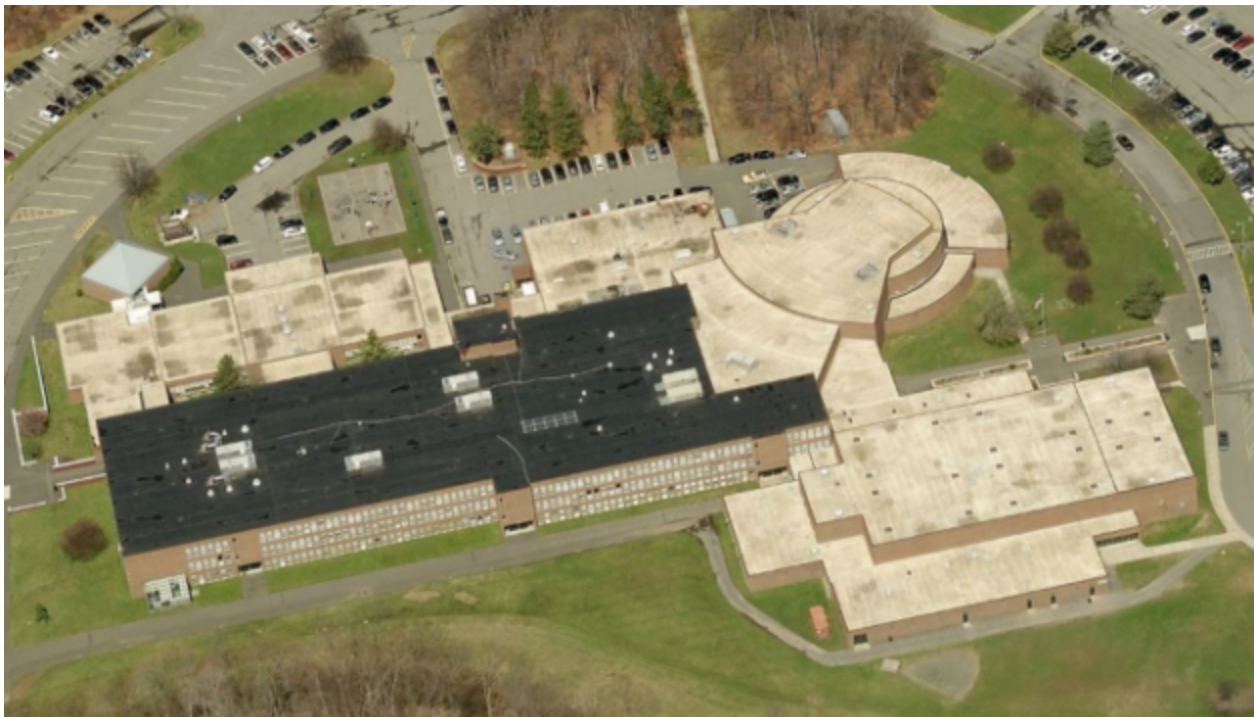
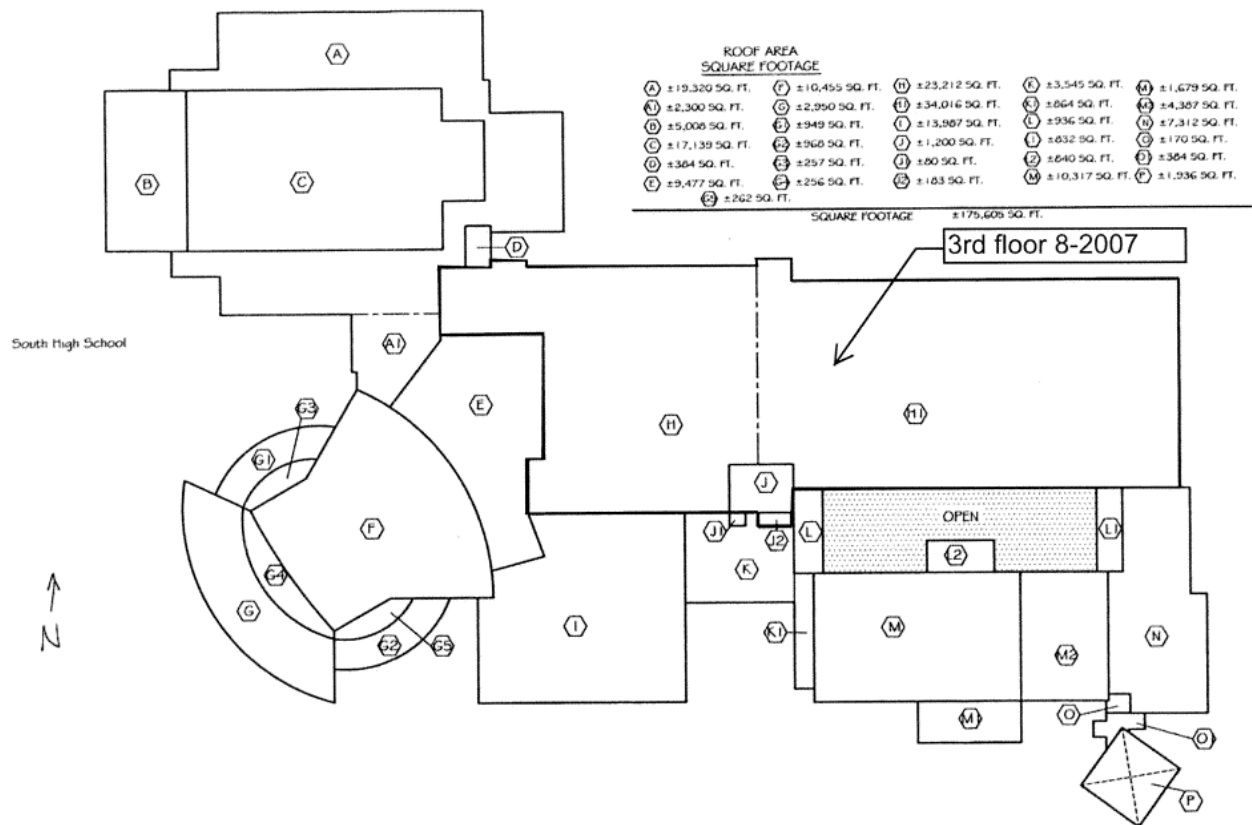
Clarkstown South HS**Description:**

- A. Original Vintage- Poor Condition (≈30 year old system).
- B. Main Block- Good Condition (≈8 year old system).
- C. Planetarium Addition- Good Condition (Age Unknown).
- D. Planetarium Entry- Good Condition (Age Unknown).
- E. Multiple stepped conditions above lower roofs.
- F. Existing curb reveal requires additional investigation.

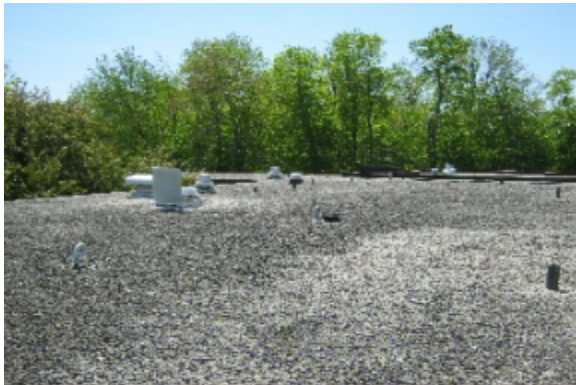
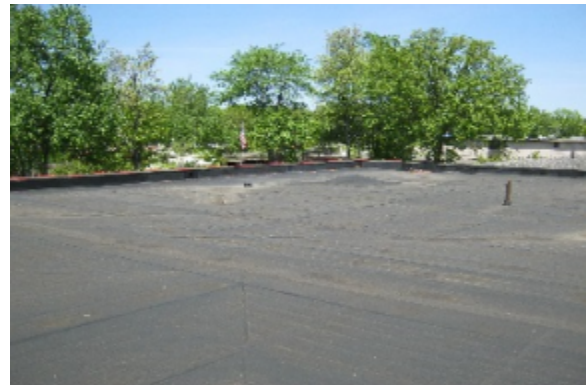
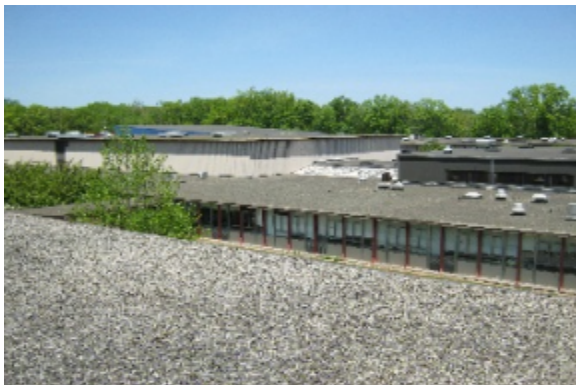
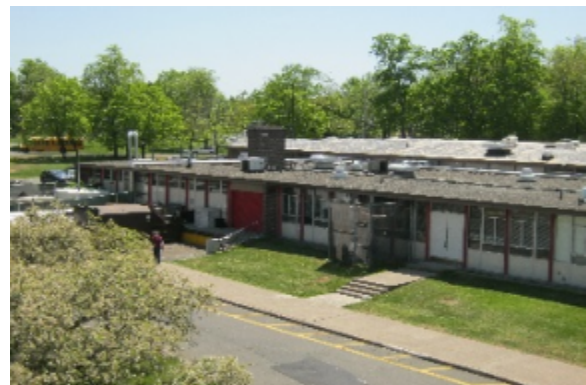
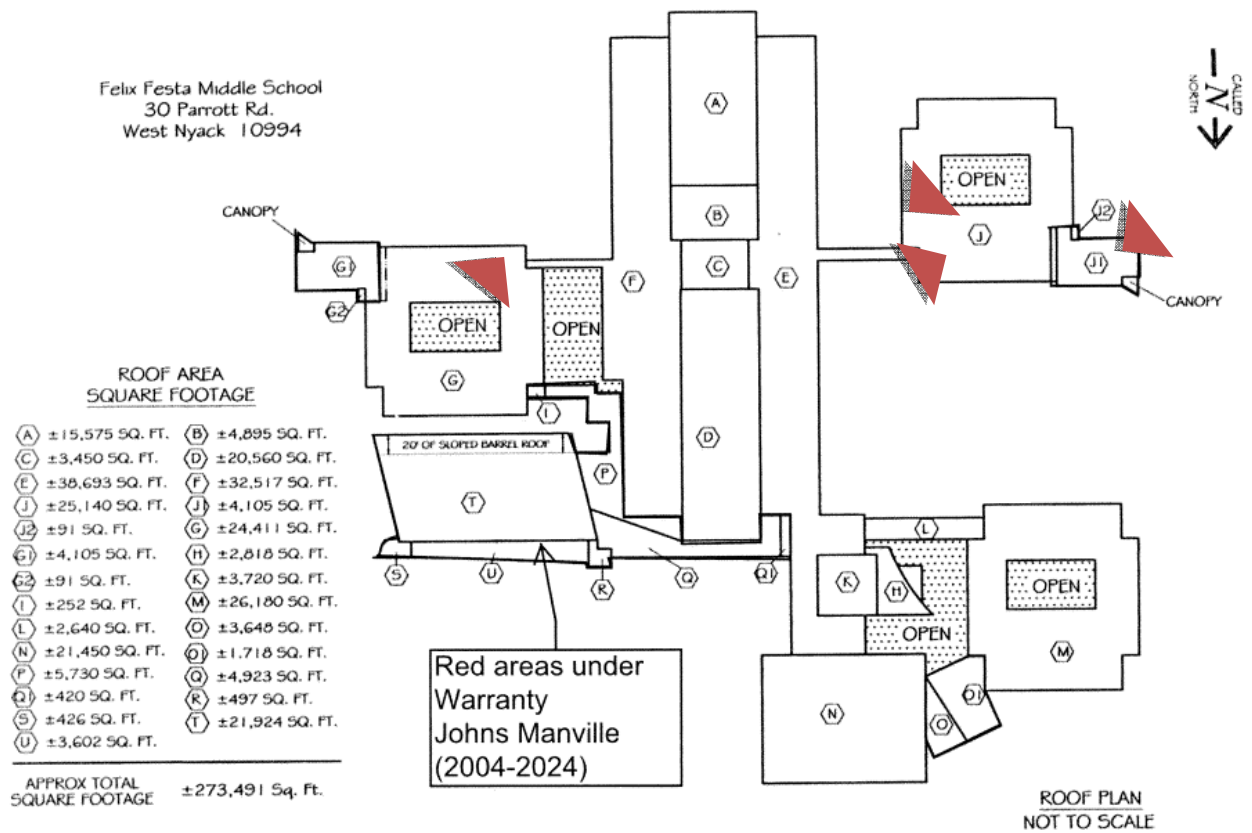
Existing Building Description Felix Festa MS

- A. Original Vintage- Poor Condition (≈30 year old system).
- B. Additions- Good Condition (≈10 year old system).
- C. Multiple stepped conditions above lower roofs.
- D. Exposed mechanical piping.
- E. Existing curb reveal is insufficient for adequate flashing as directed by current manufacturer's standards.

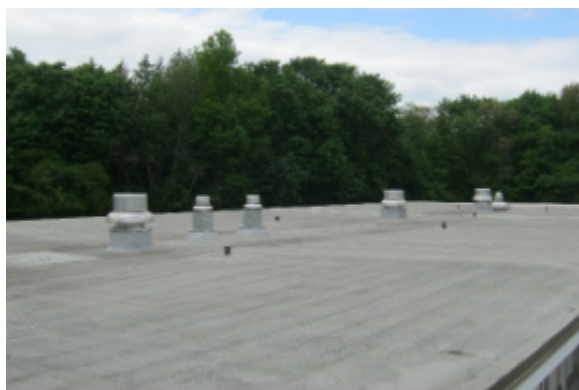
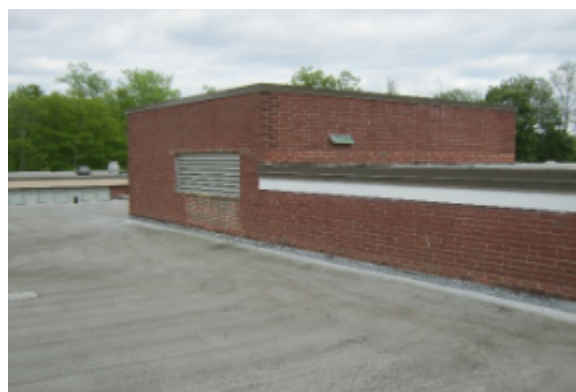
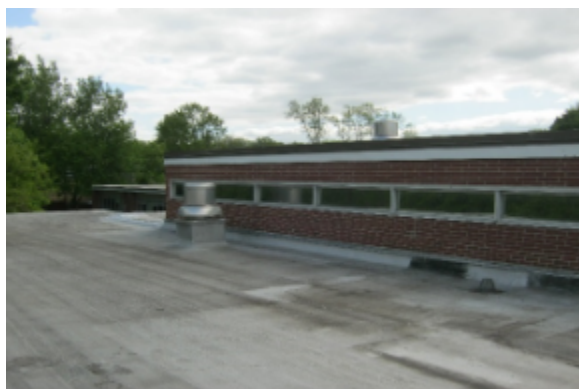
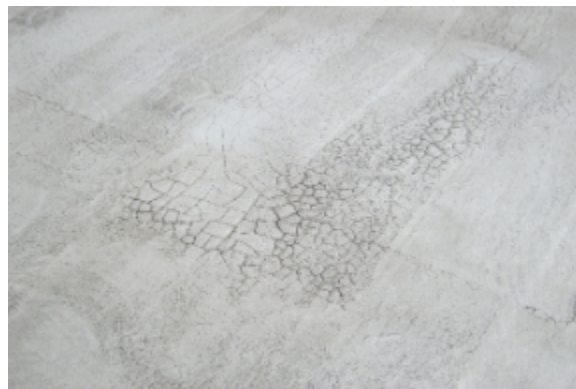
Bardonia ES**Description:**

- A. Original Vintage- Fair Condition (≈10 year old system under warranty).
- B. (2) Stepped conditions above lower roofs.
- C. Noticeable 'alligatoring' in several locations.
- D. Noticeable 'ponding' stains in several locations.

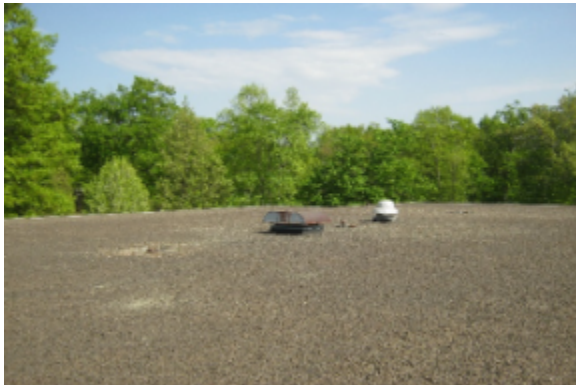
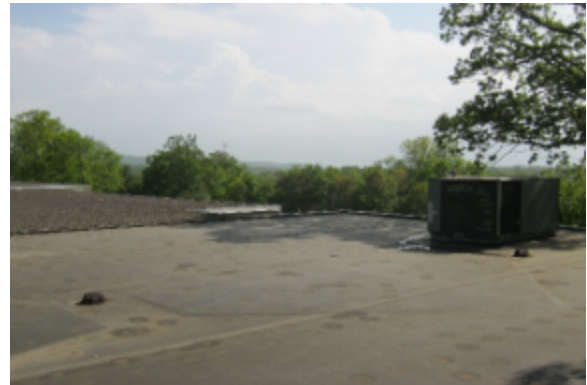
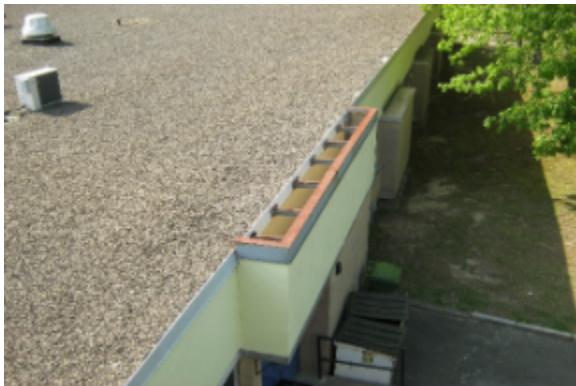
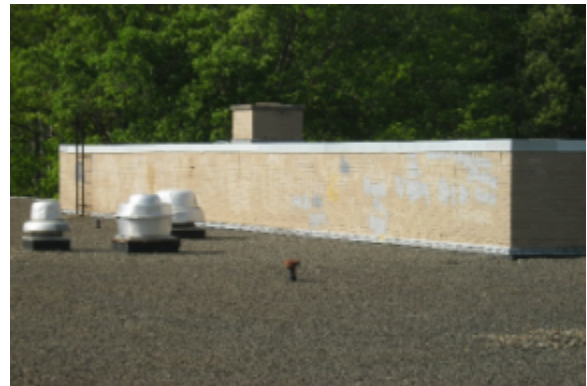
Lakewood ES

- A. Original Vintage- Poor Condition (≈30 year old system).
- B. Addition- Good Condition (≈15 year old system).
- C. Small projections covered in EPDM (≈30 year old system).
- D. (1) Stepped condition above lower roof.
- E. Existing curb reveal requires additional investigation, newer curb penetrations are acceptable.

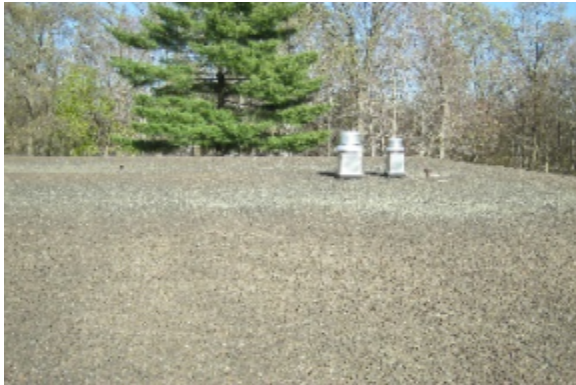
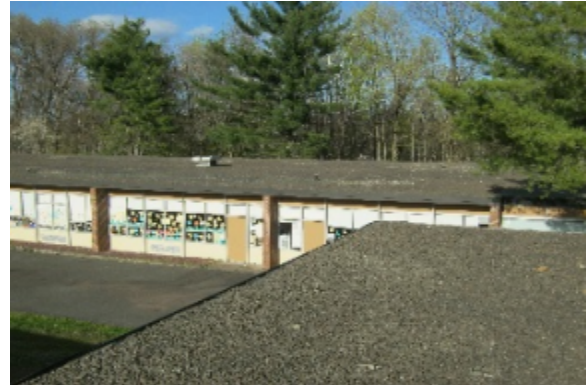
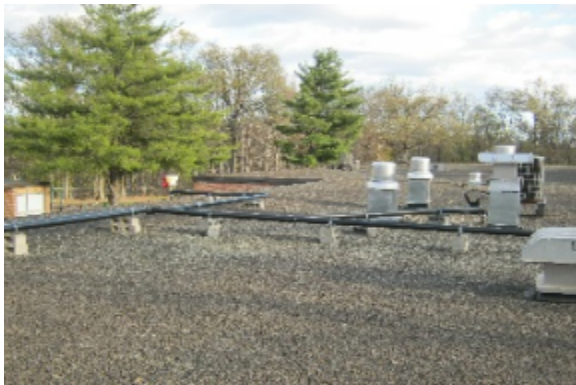
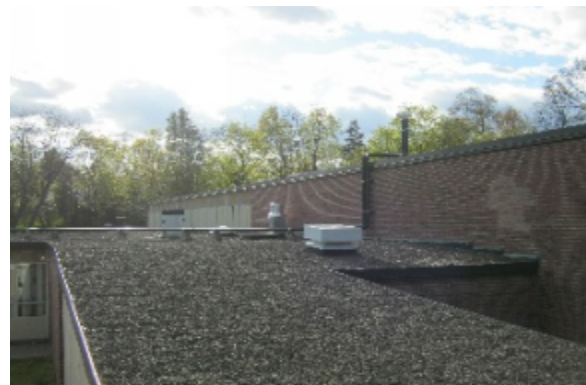
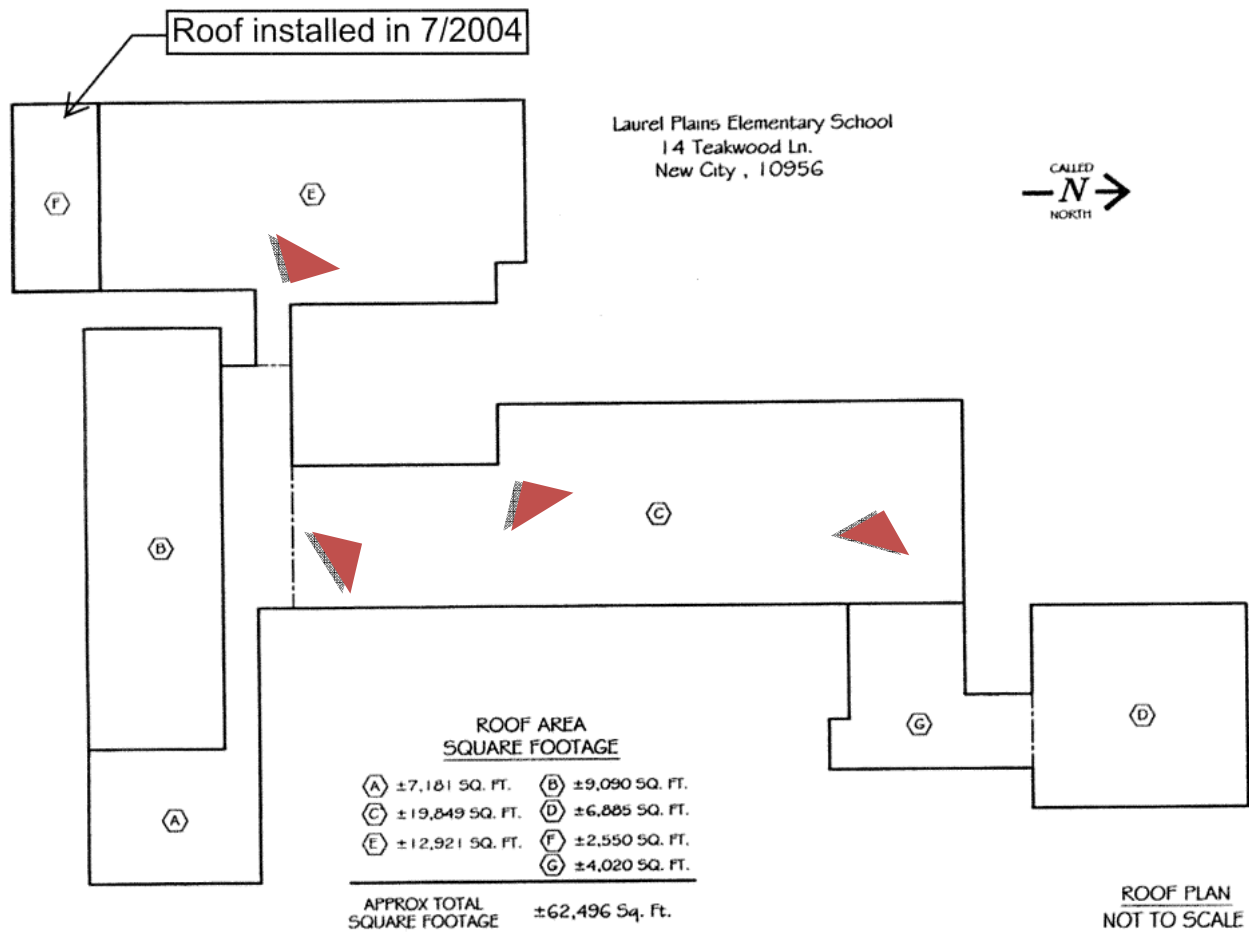
Laurel Plains ES

- A. Original Vintage- Poor Condition (≈30 year old system).
- B. Addition- Good Condition (≈11 year old system).
- C. Exposed sanitary vent lines
- D. (1) Stepped condition above lower roof.
- E. Existing curb reveal requires additional investigation, newer curb penetrations, are acceptable.

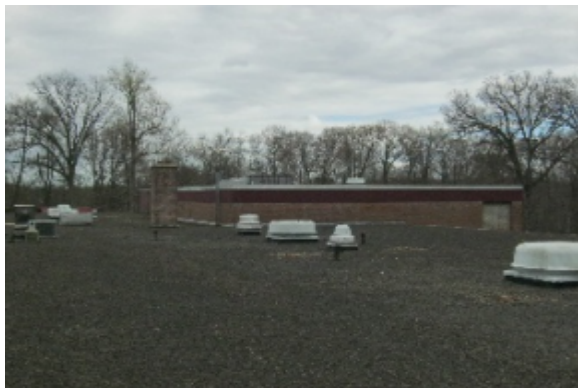
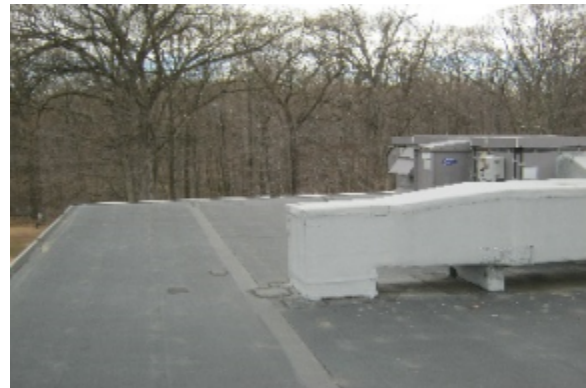
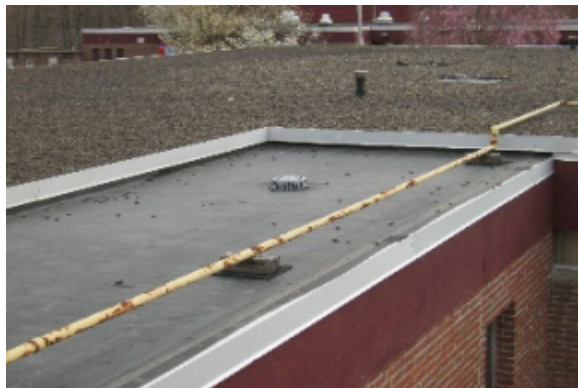
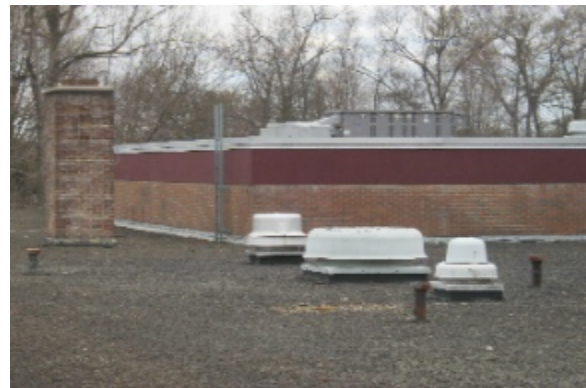
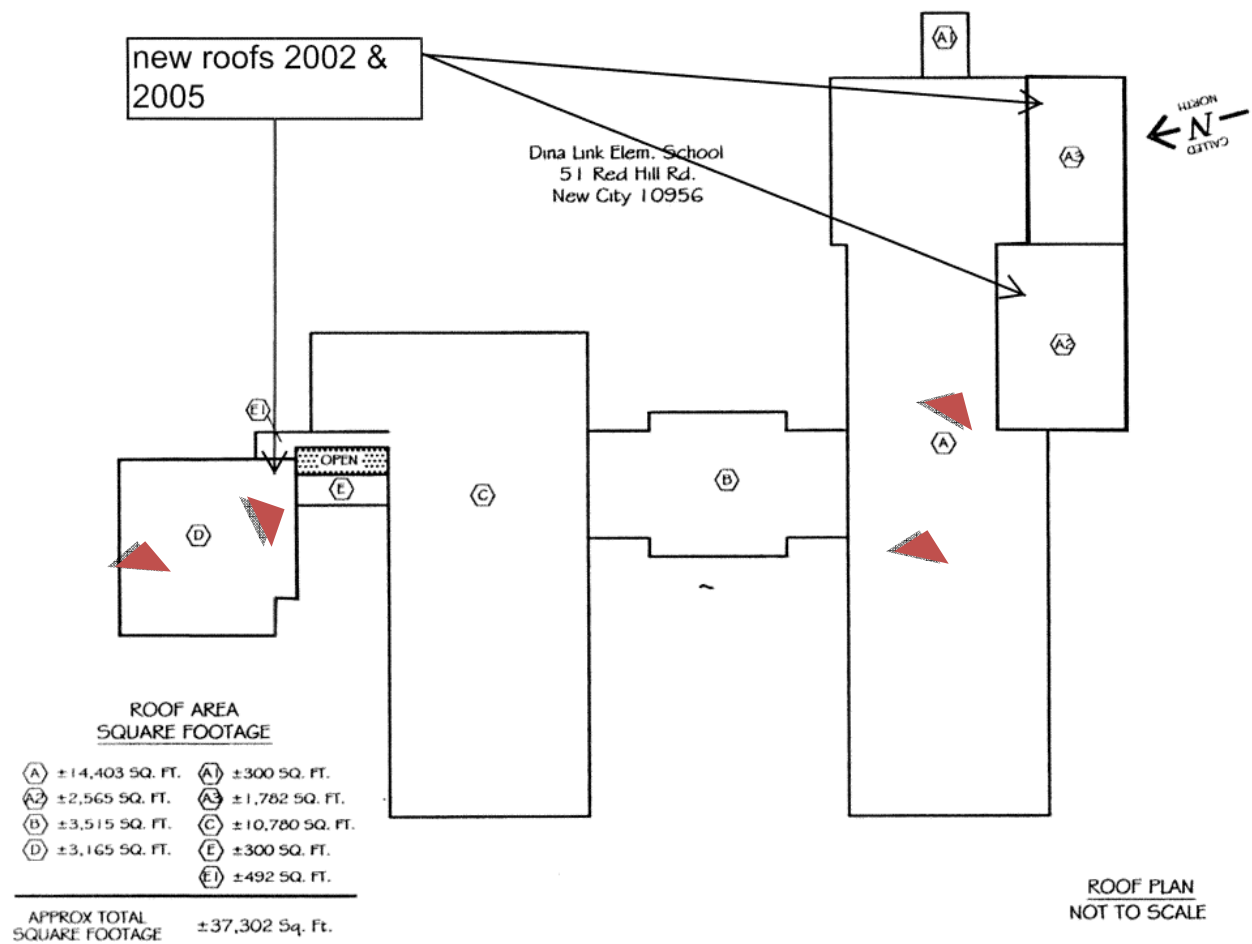
Dina Link ES

- A. Original Vintage- Poor Condition (≈30 year old system).
- B. Additions- Good Condition (≈10 year old system)).
- C. Exposed gas piping.
- D. (1) Stepped condition above lower roof.
- E. Existing curb reveal is insufficient for adequate flashing as directed by current manufacturer's standards.

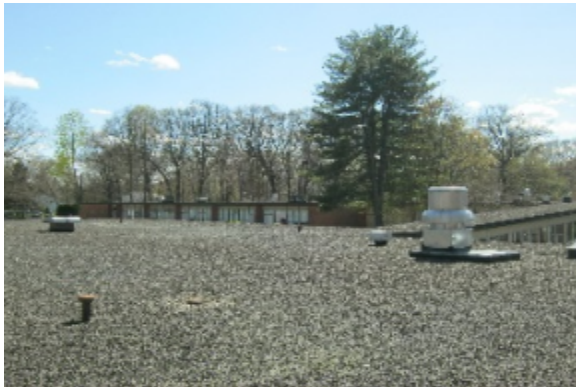
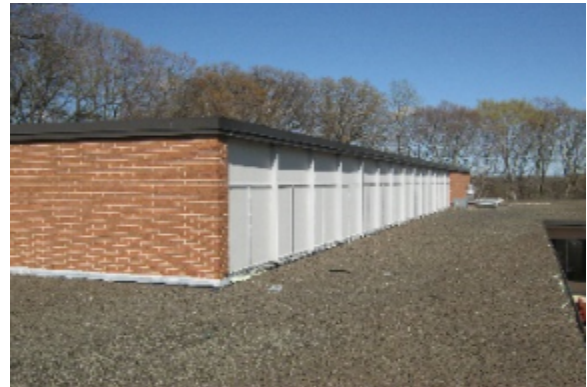
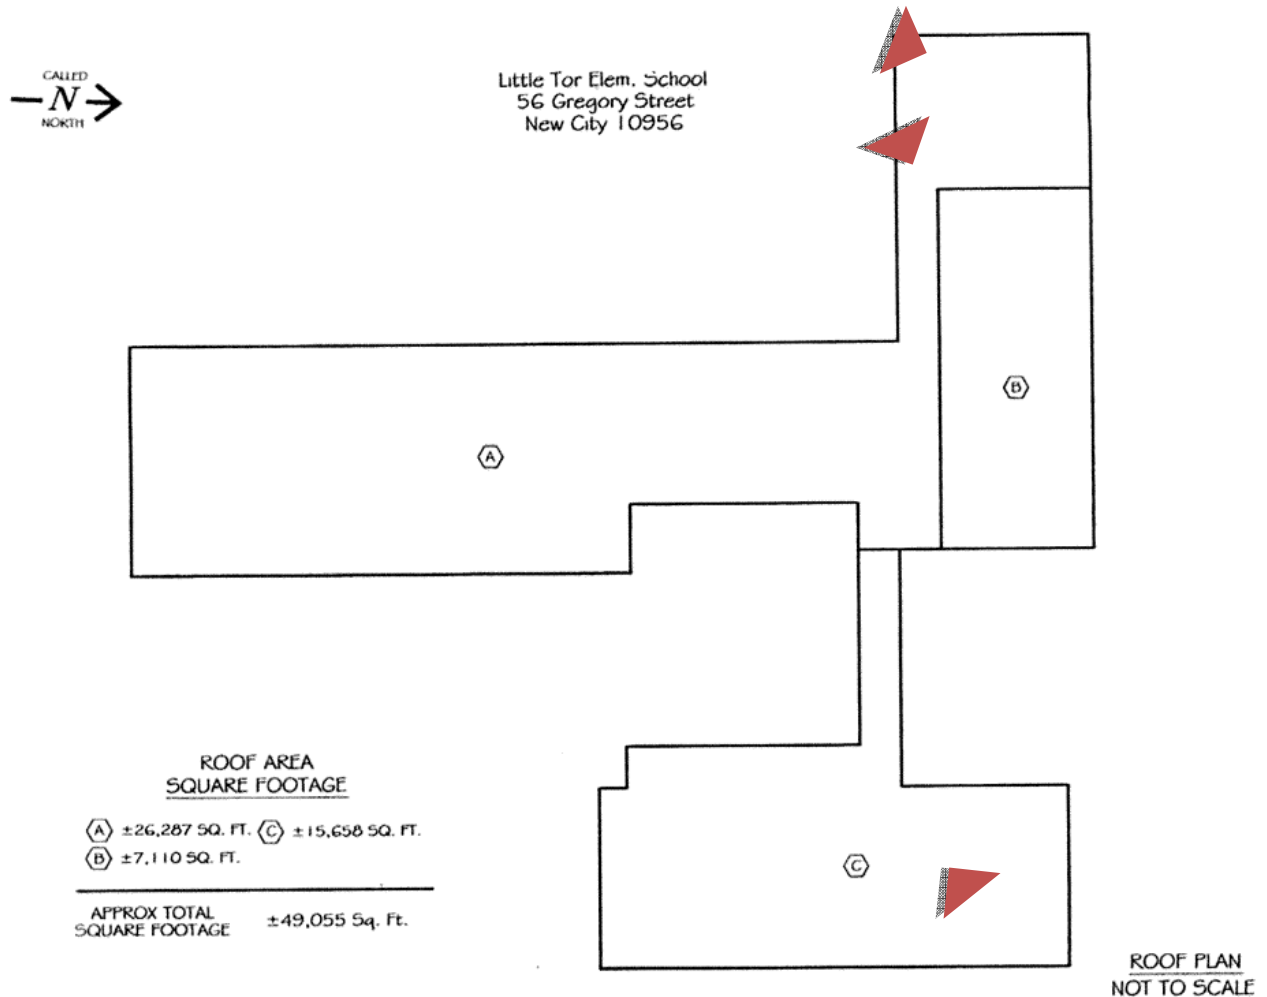
Little Tor ES

- A. Original Vintage- Poor Condition (≈30 year old system).
- B. (1) Stepped condition above lower roof.
- C. Existing curb reveal is insufficient for adequate flashing as directed by current manufacturer's standards.

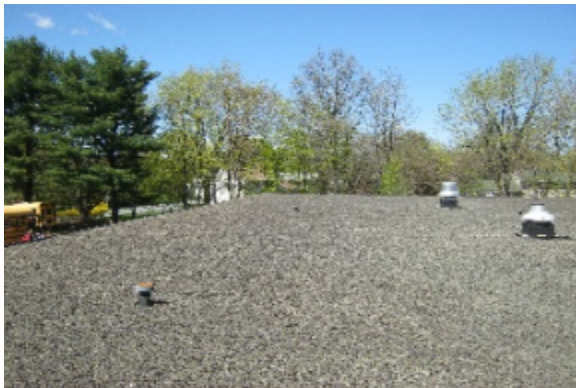
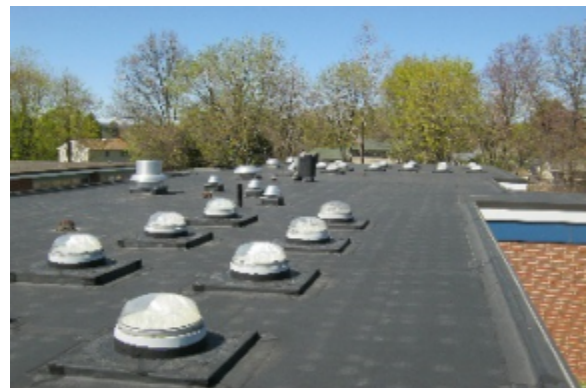
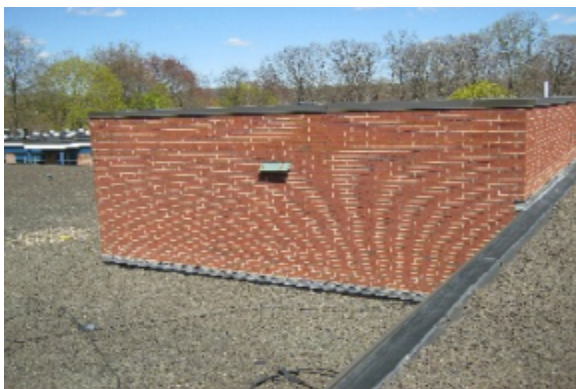
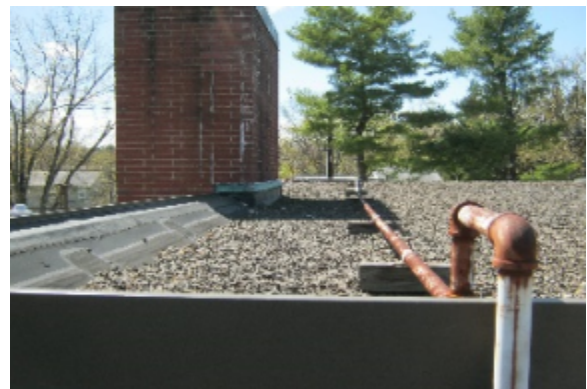
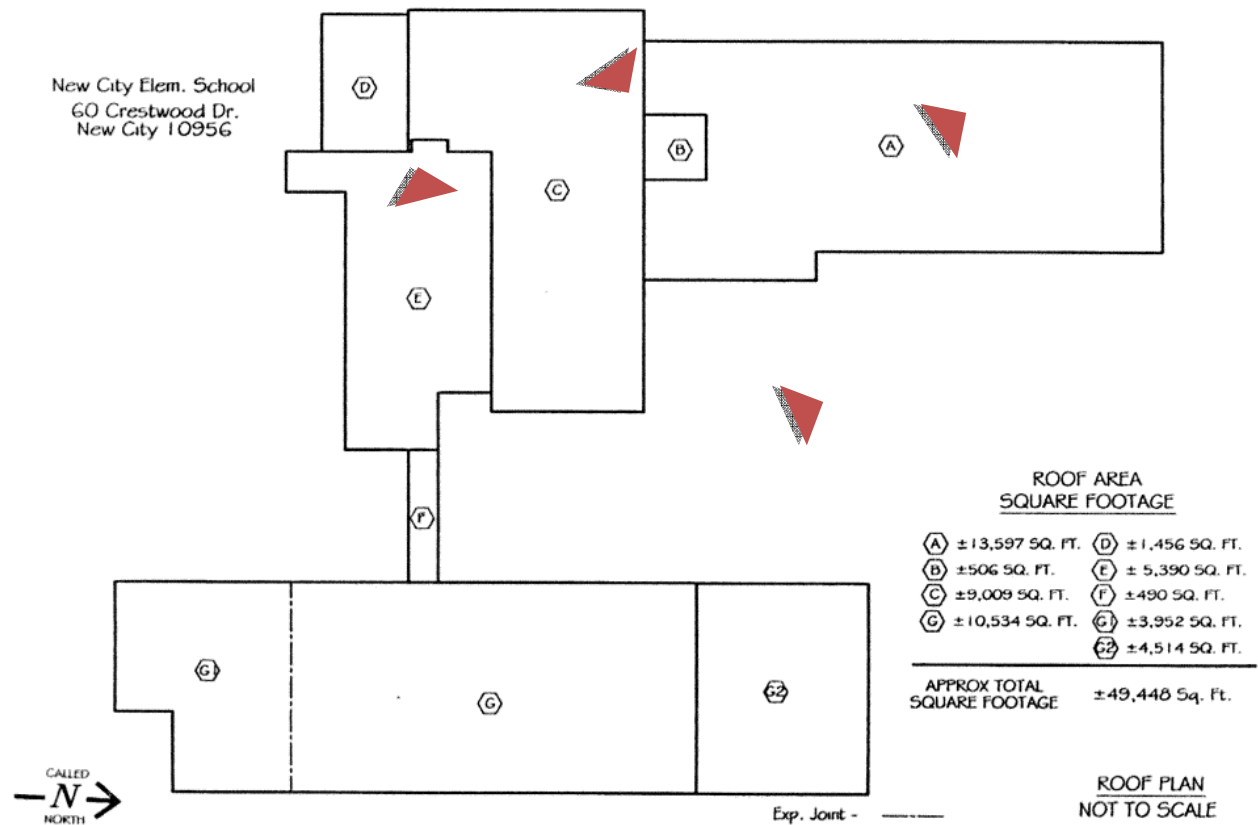
New City ES

- A. Original Vintage- Poor Condition (≈30 year old system).
- B. Addition- Good Condition (Age Unknown).
- C. (1) Stepped condition above lower roof.
- D. Exposed gas piping.
- E. Existing curb reveal is insufficient for adequate flashing as directed by current manufacturer's standards.

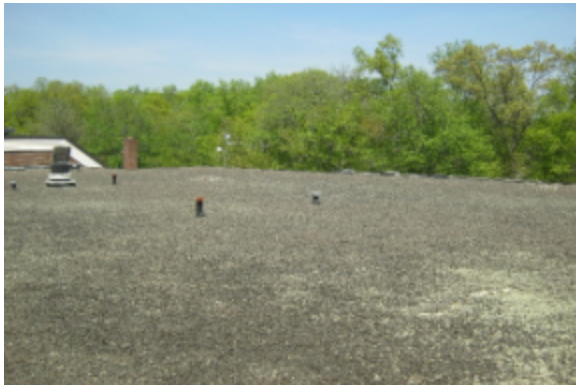
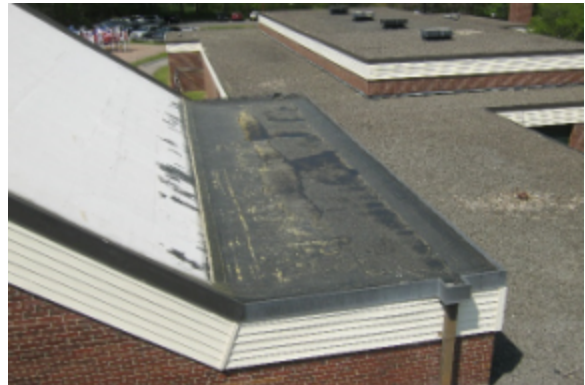
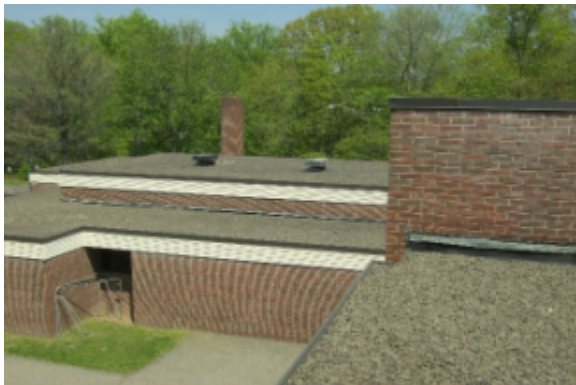
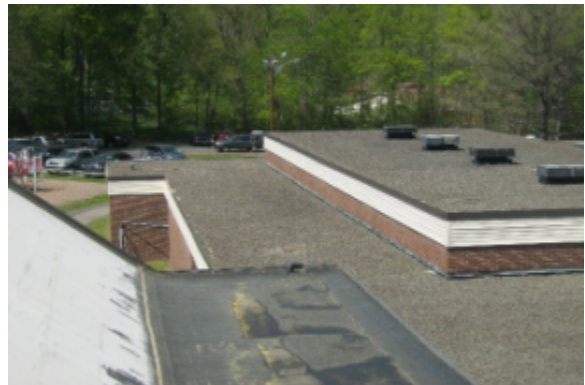
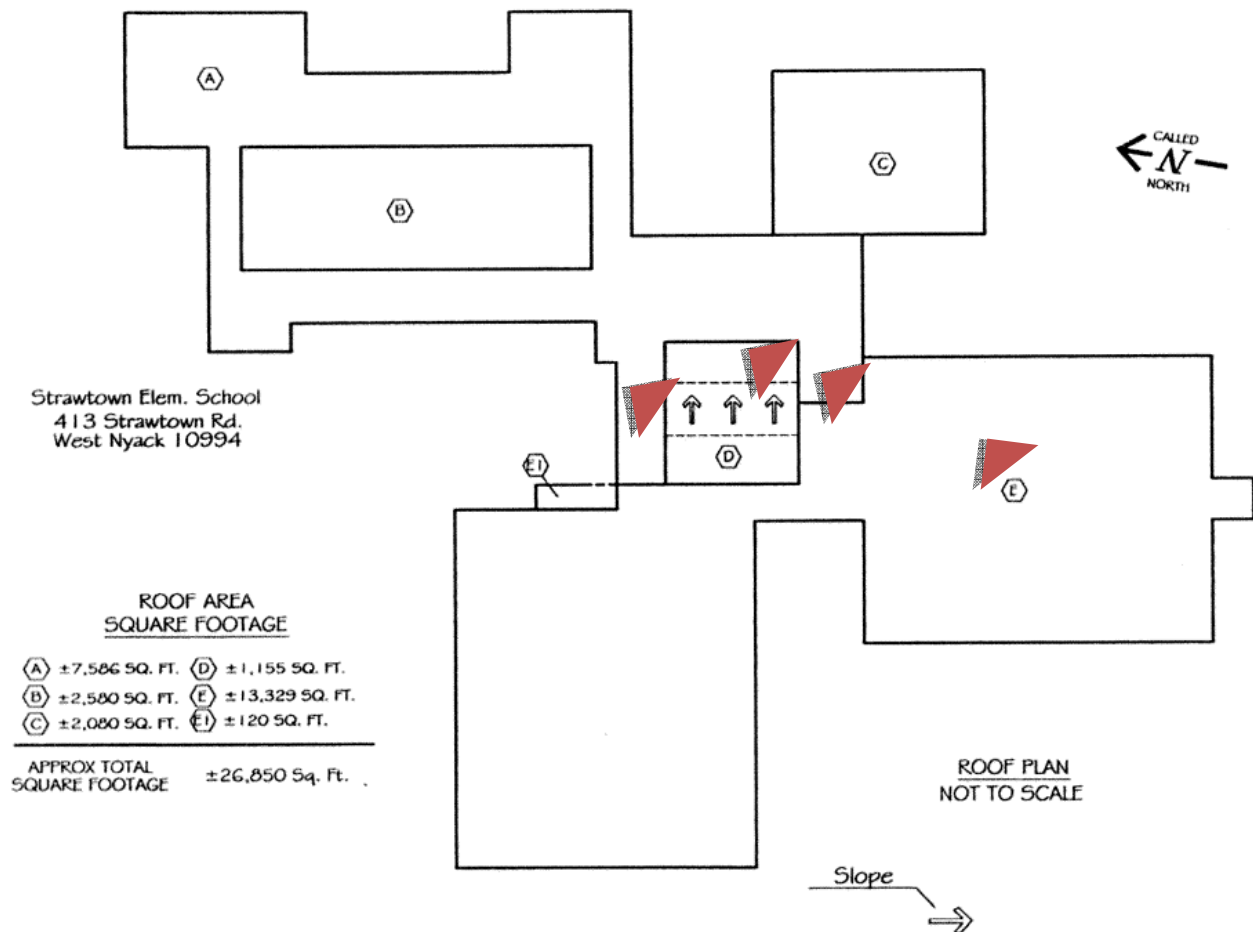
Strawtown ES

- A. Original Vintage- Poor Condition (≈30 year old system).
- B. Library & Stair Tower- Poor Condition (≈30 year old system).
- C. (2-3) stepped conditions above lower roofs.
- D. Existing curb reveal requires additional investigation, some curbs are borderline concerning current manufacturer's standards.

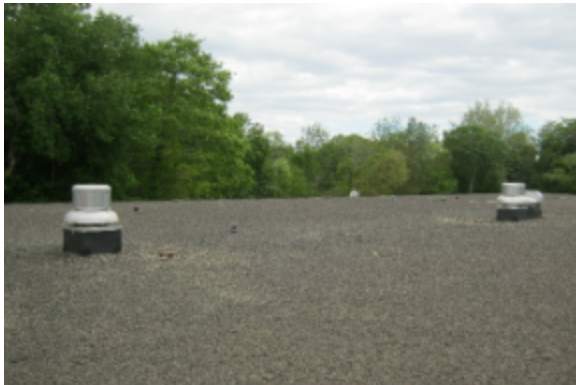
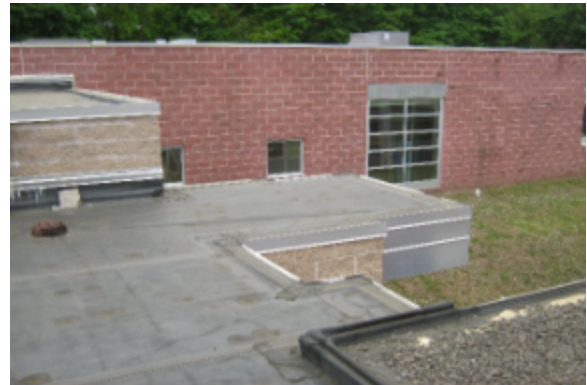
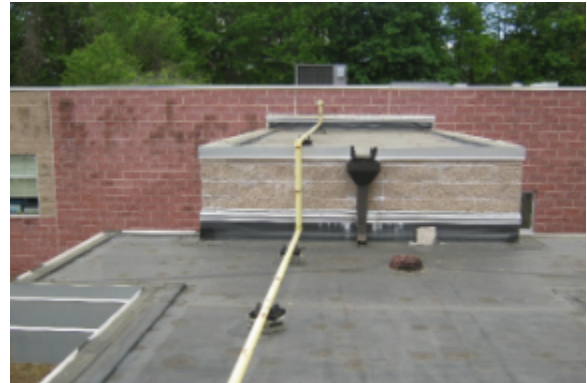
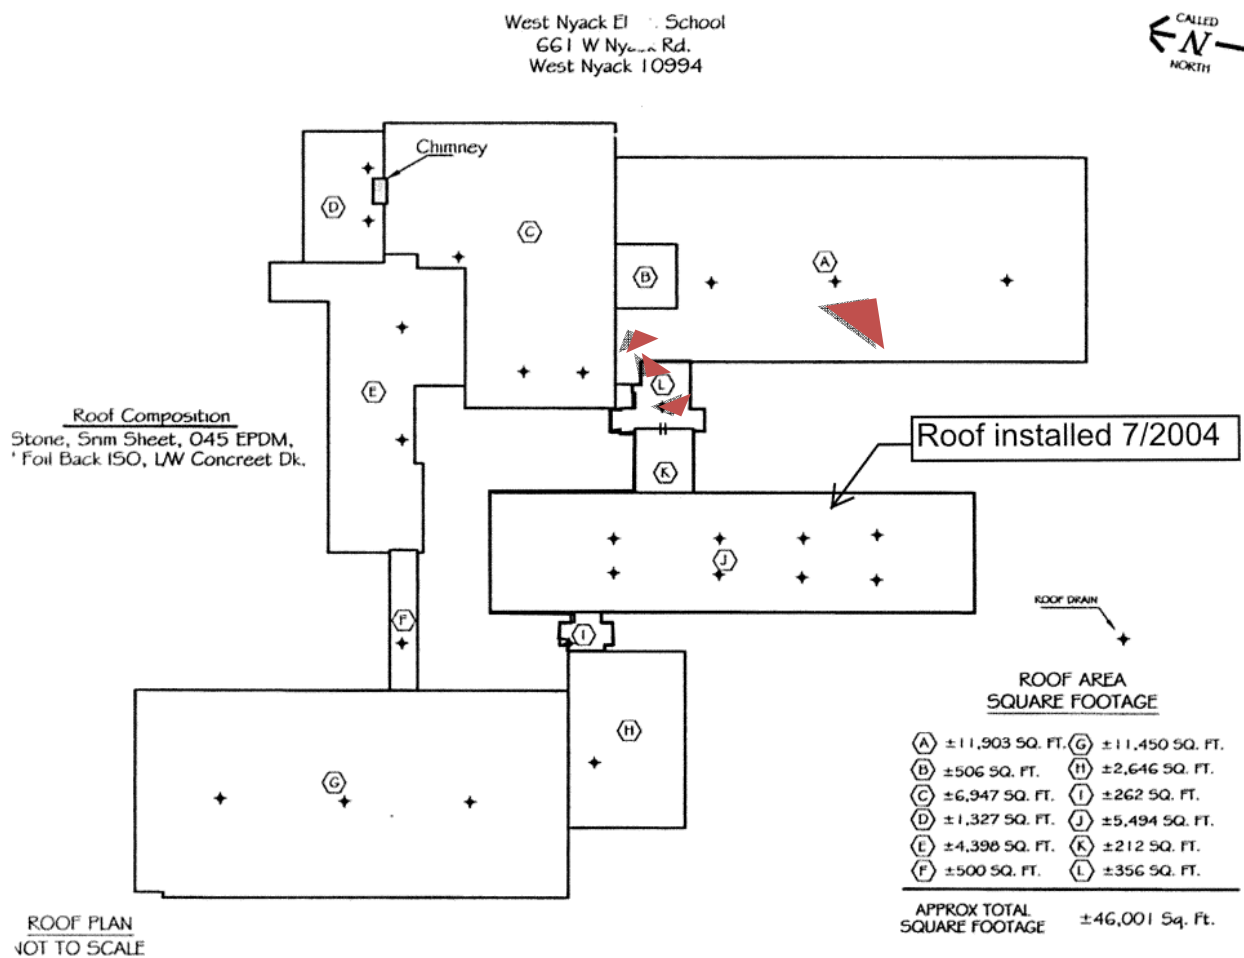
West Nyack ES

- A. Original Vintage- Poor Condition (≈30 year old system).
- B. Addition- Good Condition (≈11 year old system).
- C. (1) Stepped condition above lower roof.
- D. Exposed gas piping.
- E. Existing curb reveal requires additional investigation, newer curb penetrations, within IRMA system are acceptable.

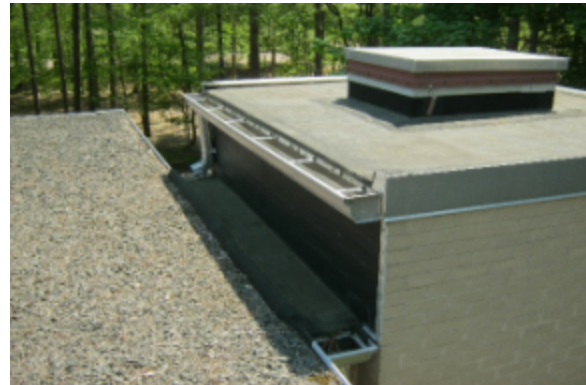
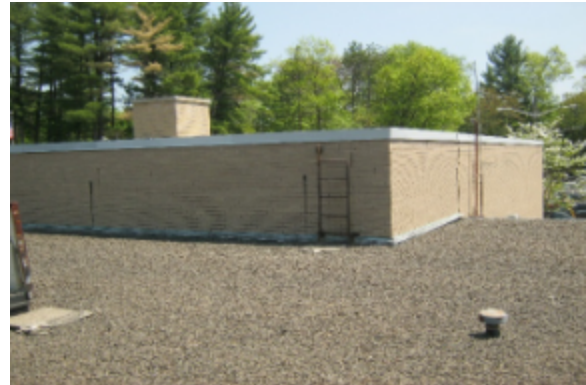
Woodglen ES

- A. Original Vintage- Poor Condition (≈30 year old system).
- B. Elevator Addition- Good Condition (≈10 year old system).
- C. Small projections covered in EPDM (Age Unknown).
- D. (1) Stepped condition above lower roof.
- E. Existing curb reveal requires additional investigation, newer curb penetrations are acceptable.

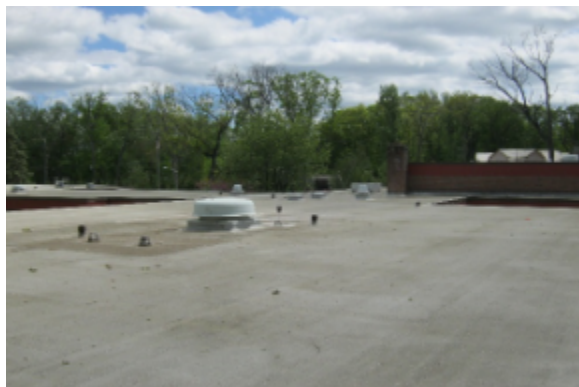
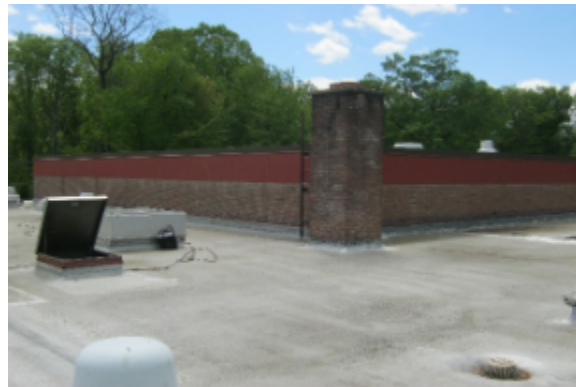
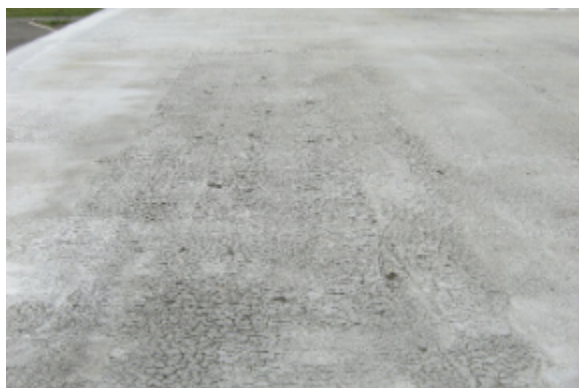
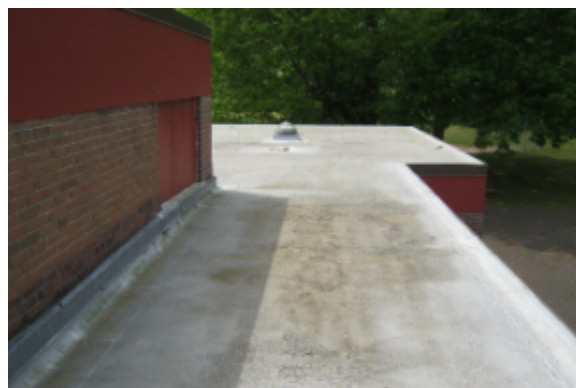
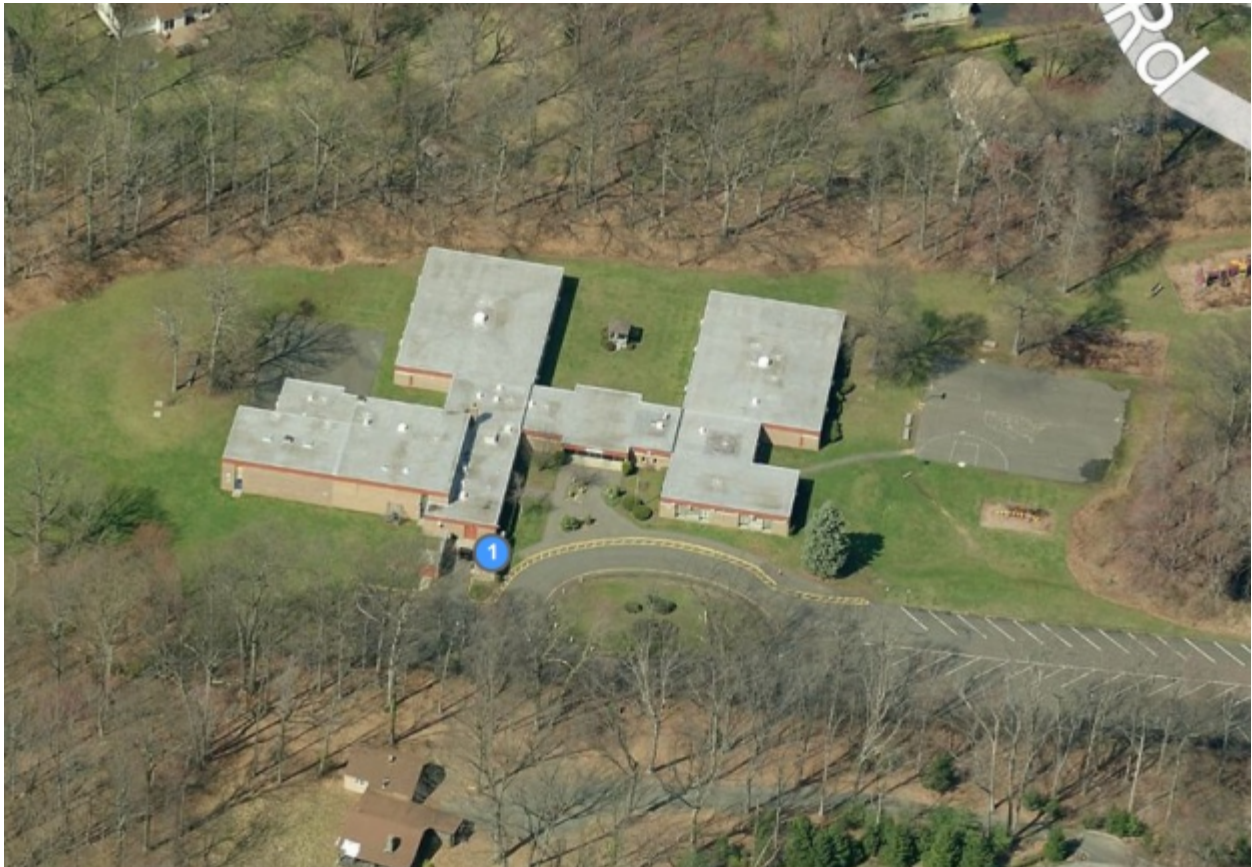
Birchwood School

- A. Original Vintage- Fair Condition (≈10 year old system under warranty?).
- B. (1) Stepped condition above lower roof.
- C. Noticeable 'alligatoring' & 'ponding' in several locations.
- D. Noticeably flat in some areas, attributing to the ponding.
