ROOF EVALUATIONS

Clarkstown Central
School District

June 2015

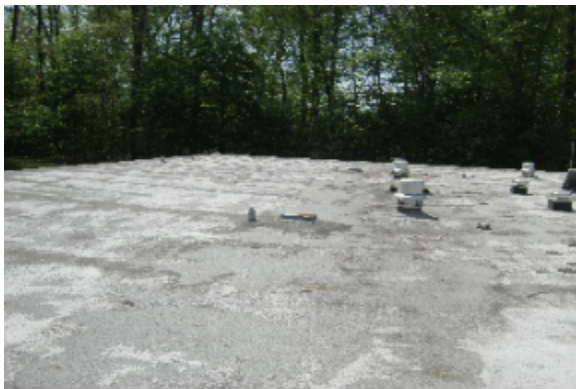
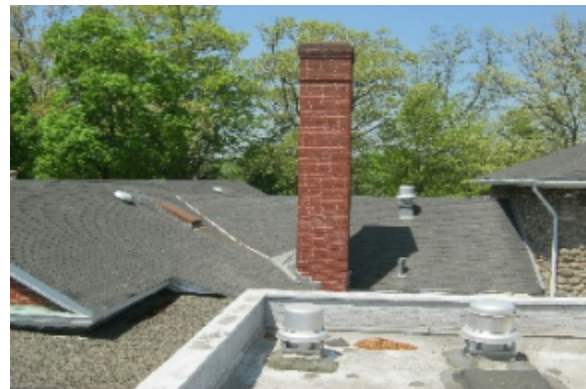
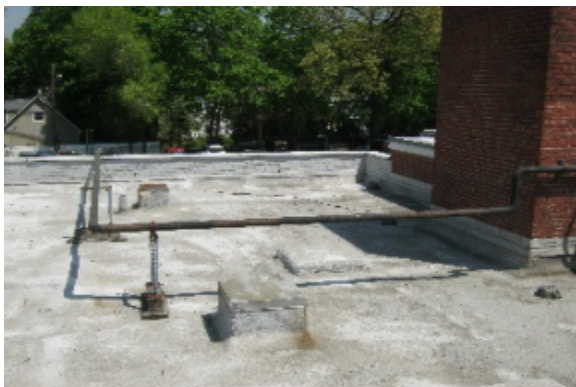
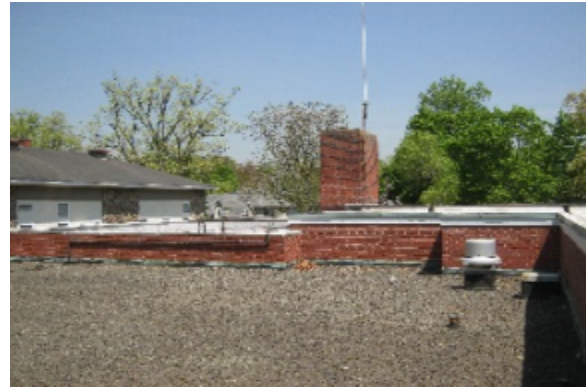
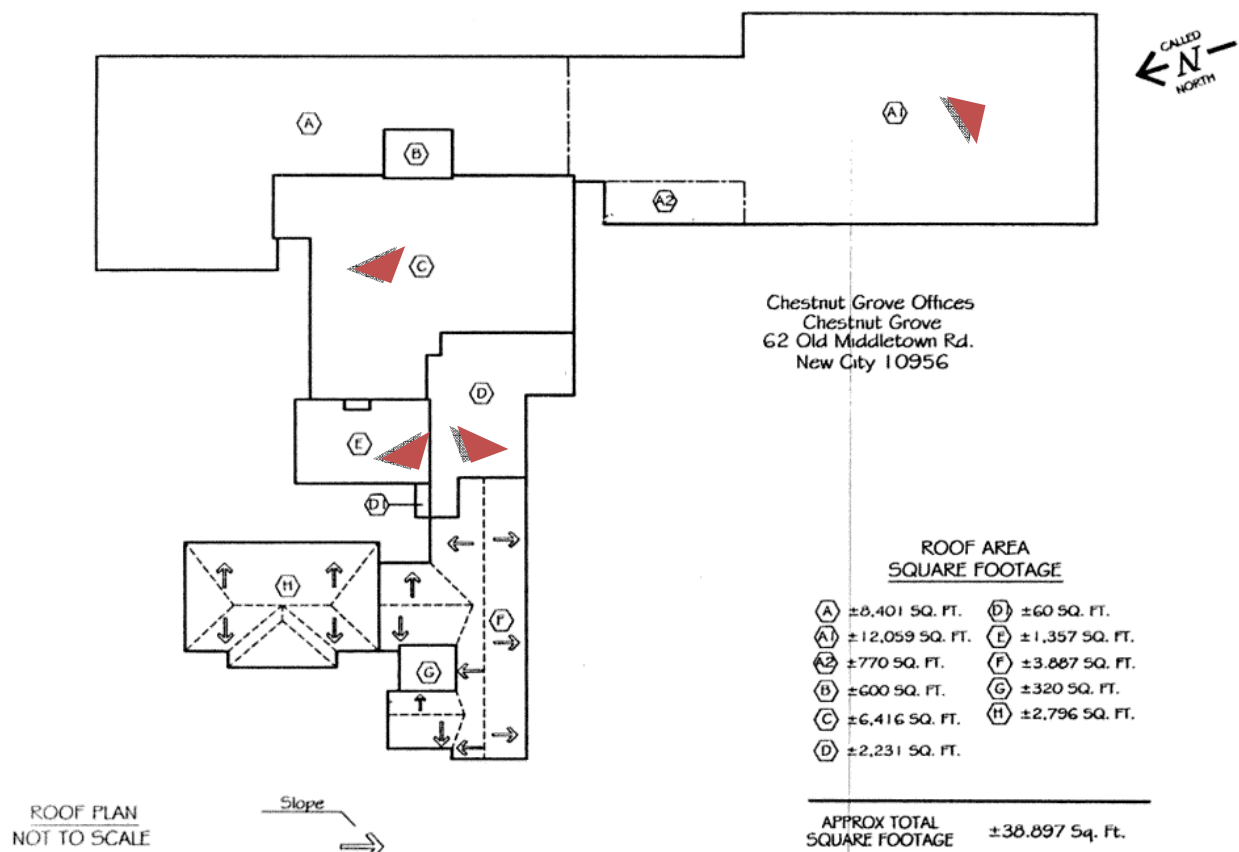
Chestnut Grove Offices

- A. Original Vintage- Poor Condition (≈33 year old system).
- B. Additions- Poor Condition (≈18 year old system, recoat?).
- C. Exposed gas piping.
- D. (1) Stepped condition above lower roof.
- E. Existing curb reveal requires additional investigation, judgment difficult with sprayed foam material.

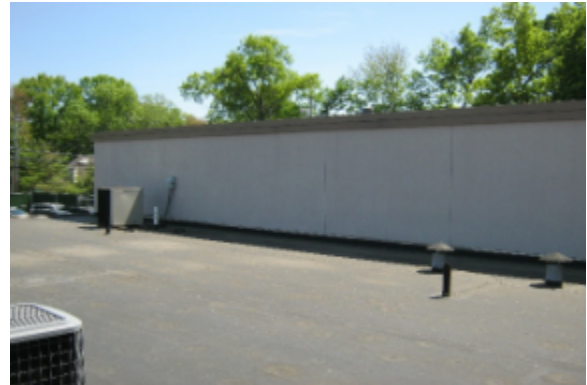
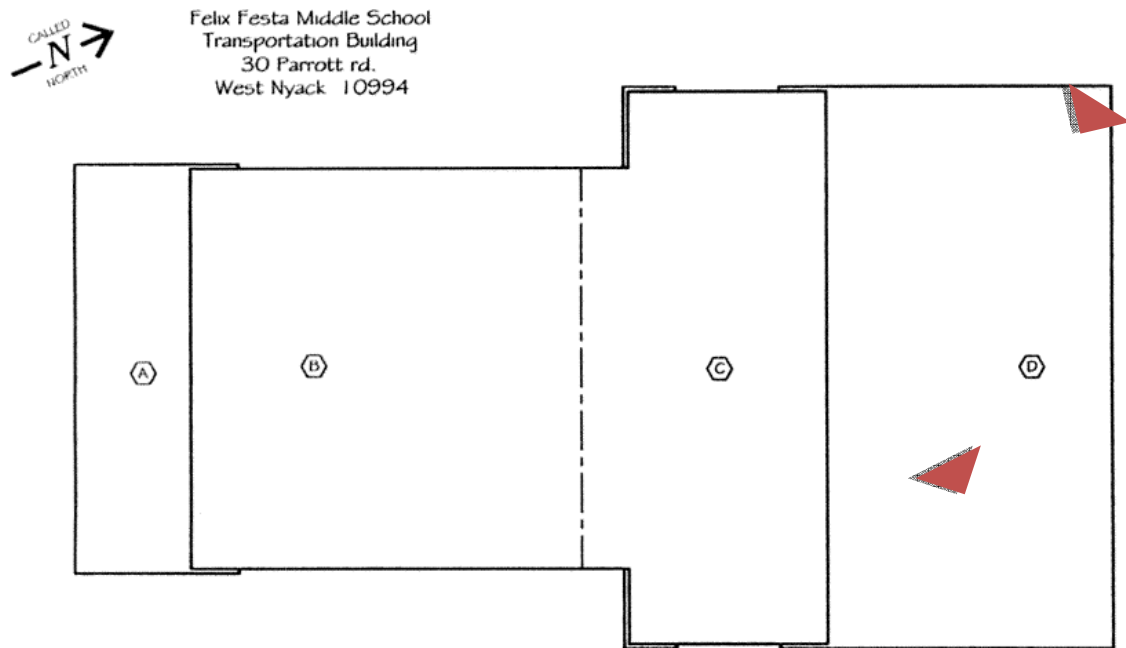
Felix Festa Transportation Garage**Description:**

- A. Original Vintage (Partial)-Fair Condition (Age Unknown).
- B. (1) Stepped condition above lower roof.
