Congers Construction

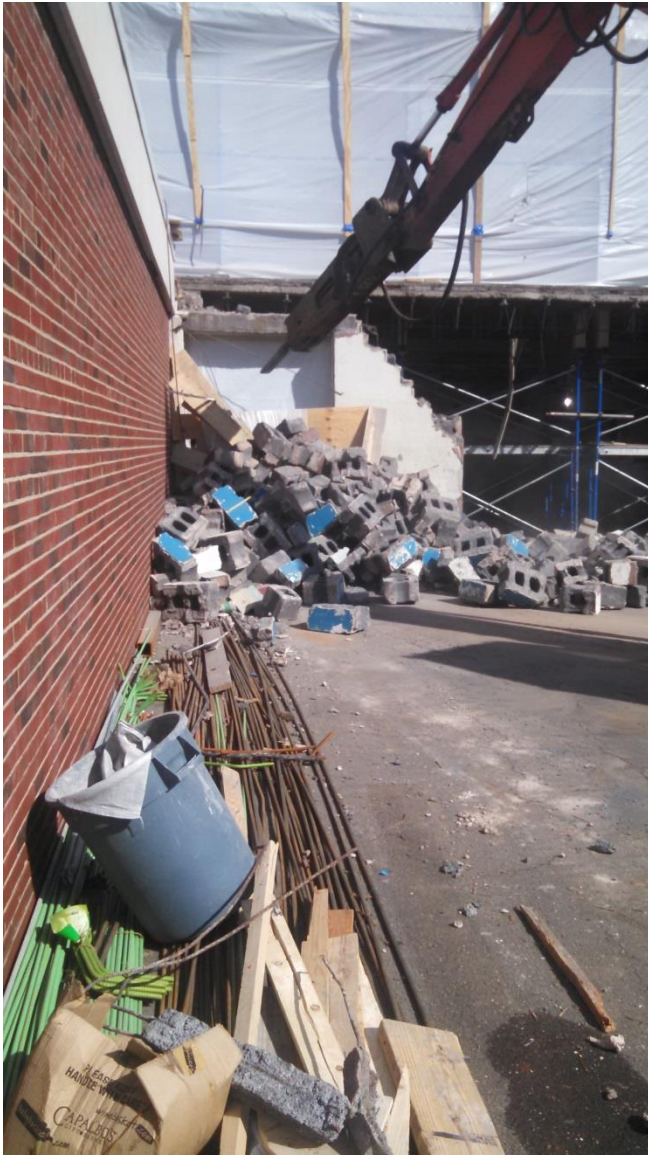
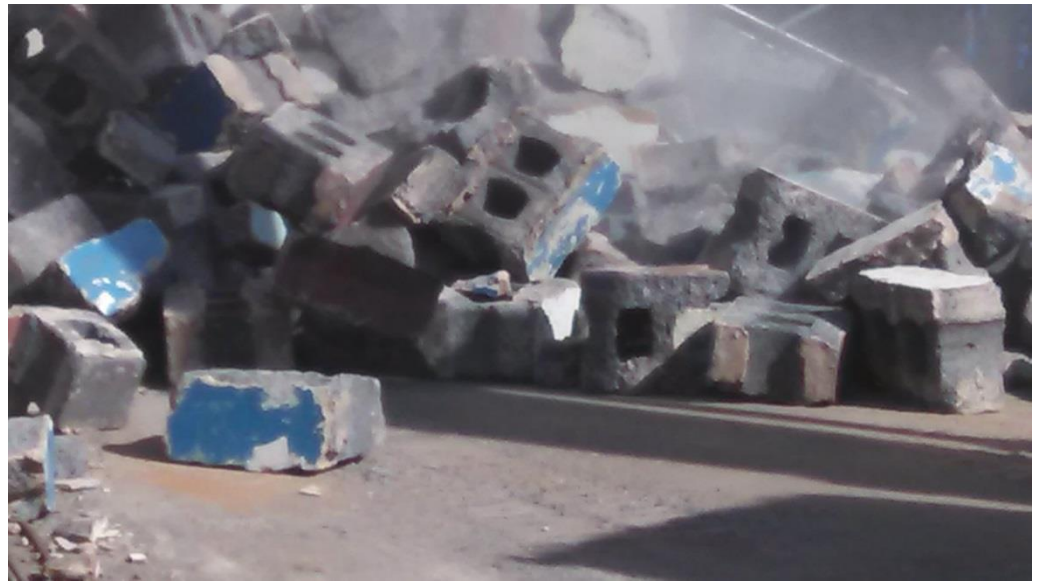
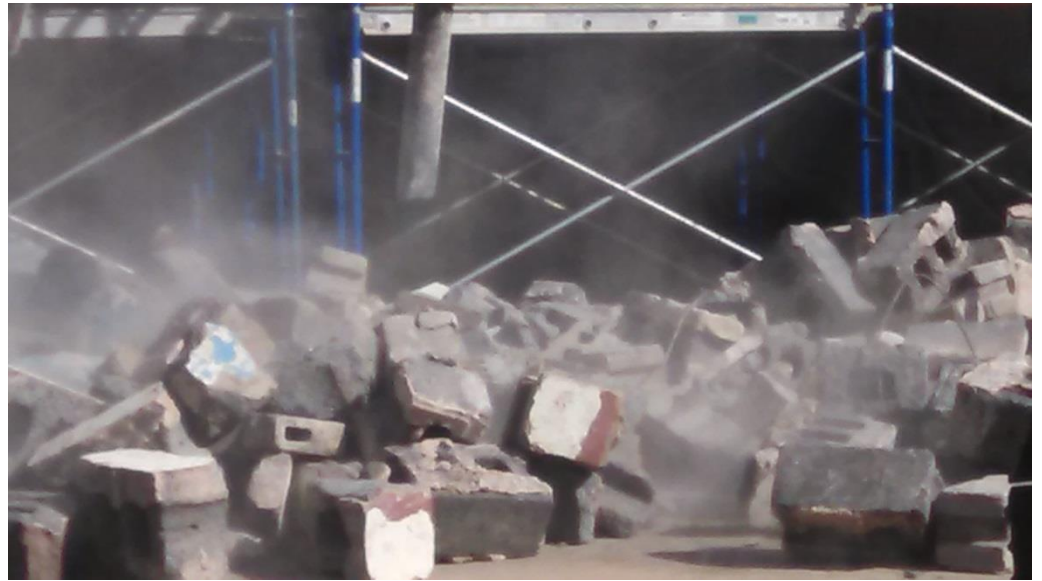
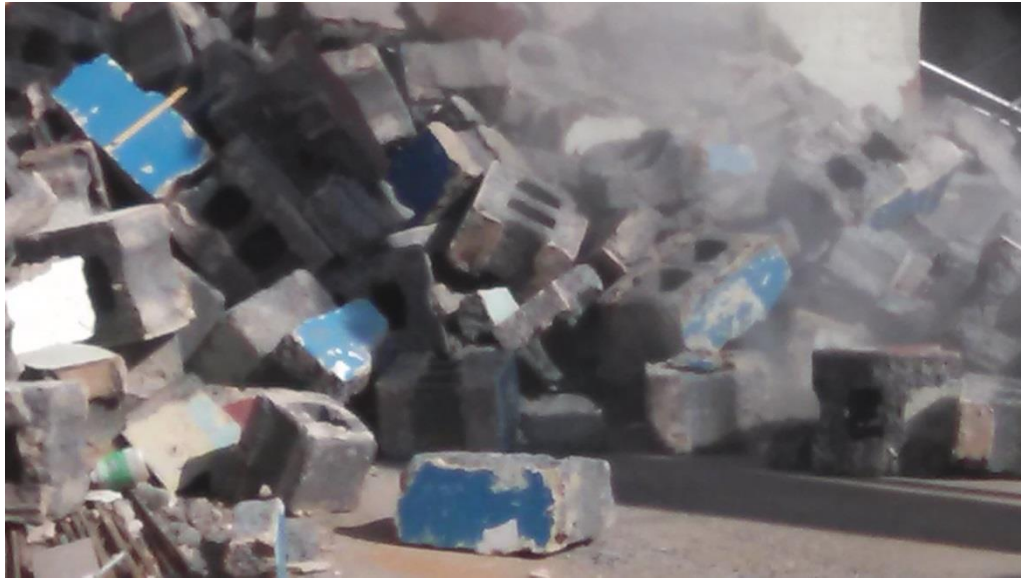
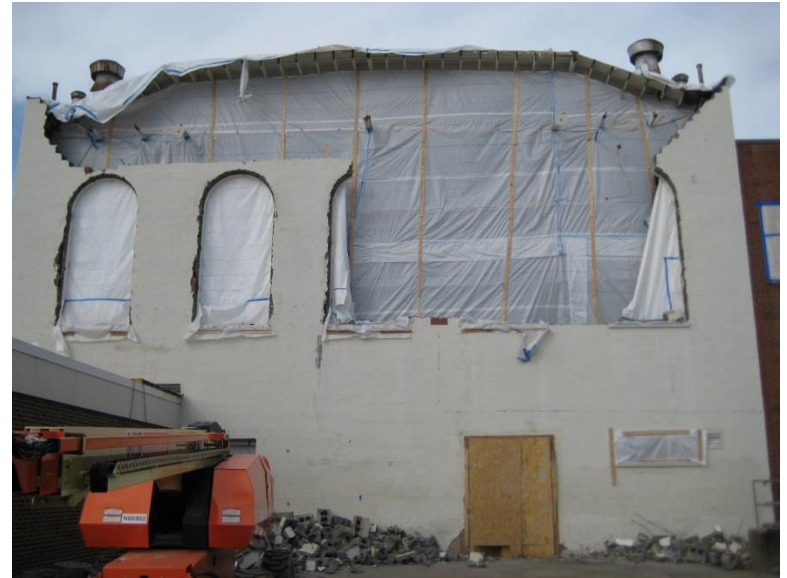
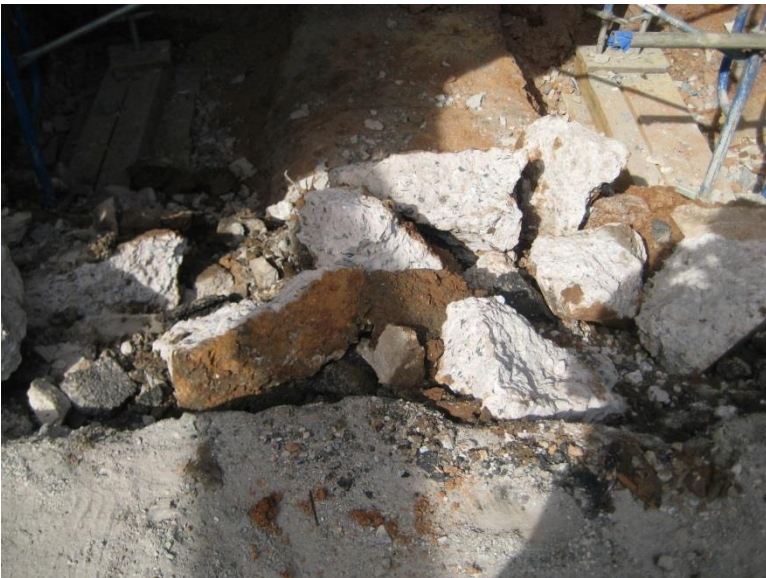
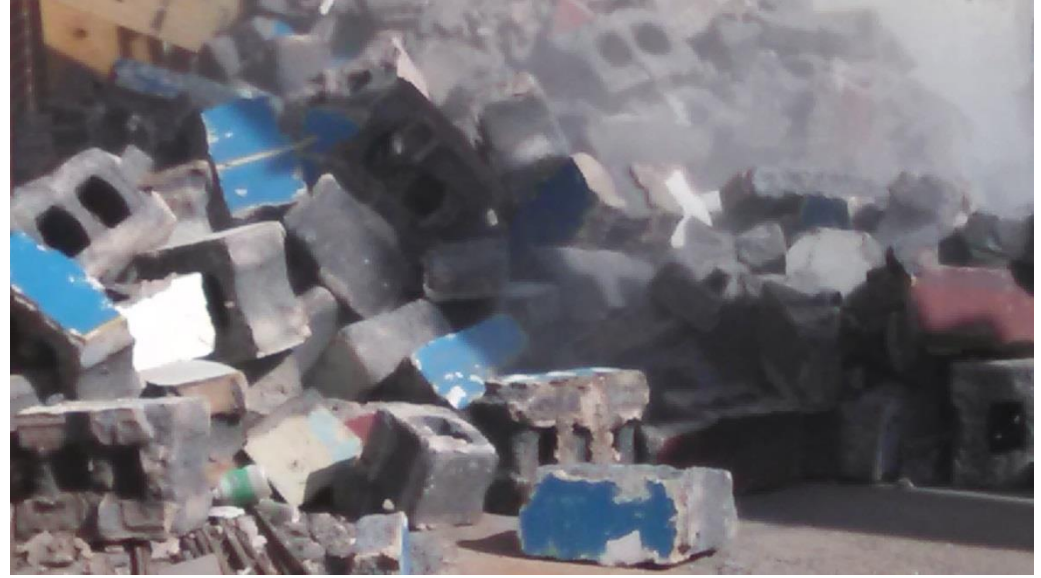
Pictures of debris from south wall demolition. No structural reinforcement in debris. No rebar, and no mortar in cinder block cores.

Pictures of debris from south wall demolition. No structural reinforcement in debris.
No rebar, and no mortar in cinder block cores.

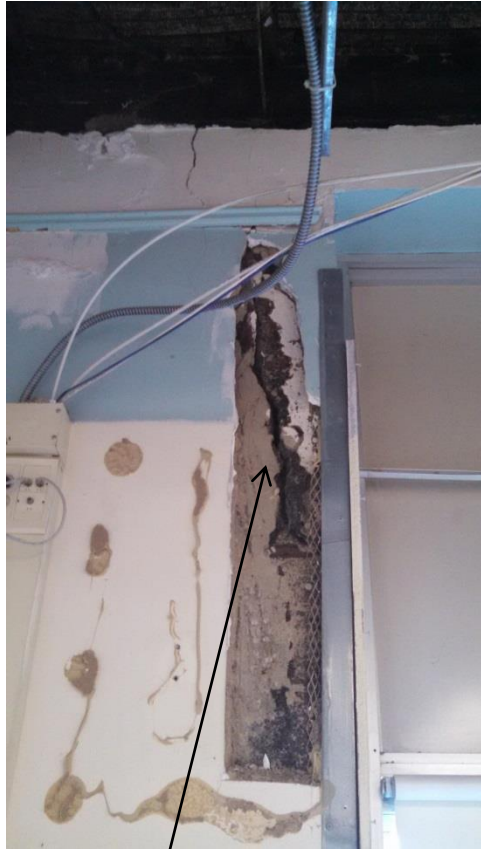
Structural crack in wall uncovered during demolition in north east classroom

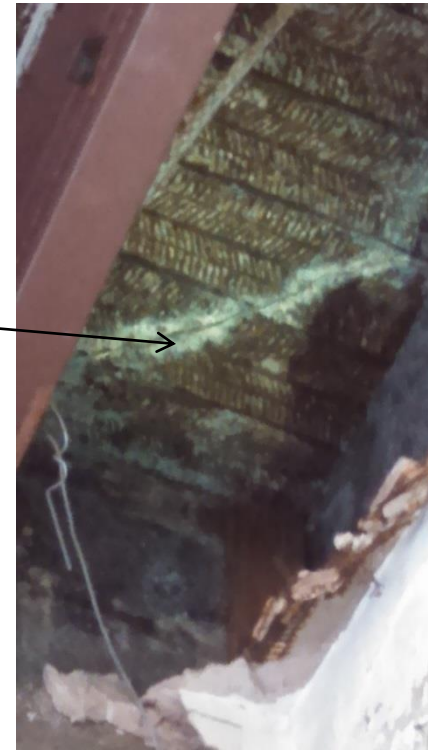
Additional cracks in lower wing block wall. Discovered when cabinets were removed.

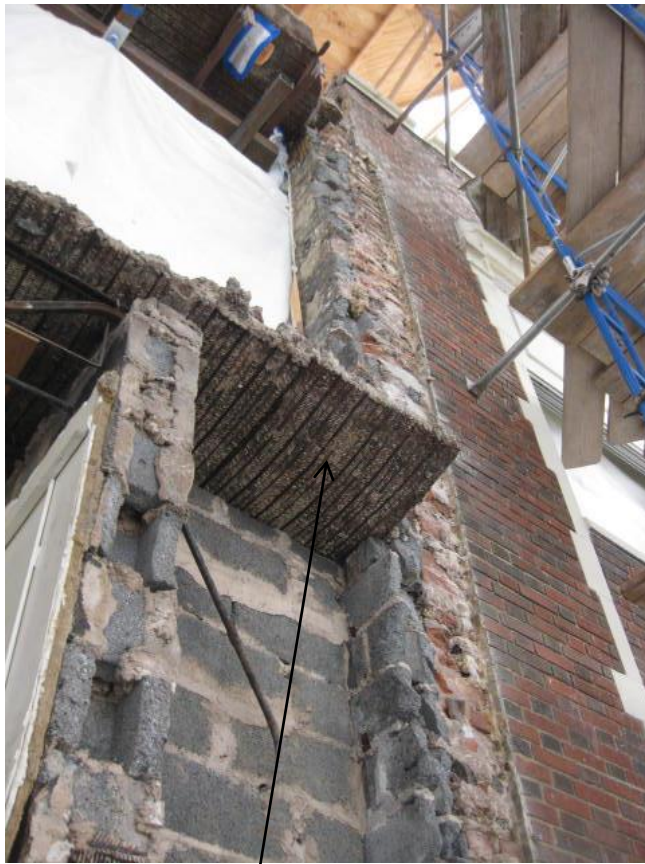
Unsupported section of 2nd
floor slab at north wall.

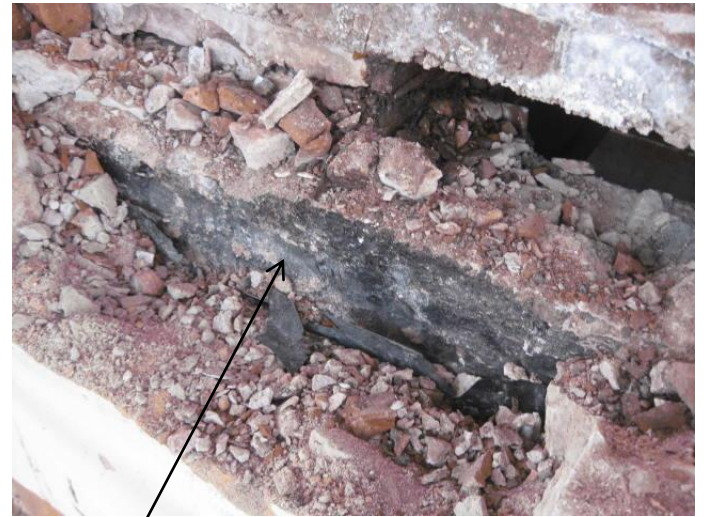
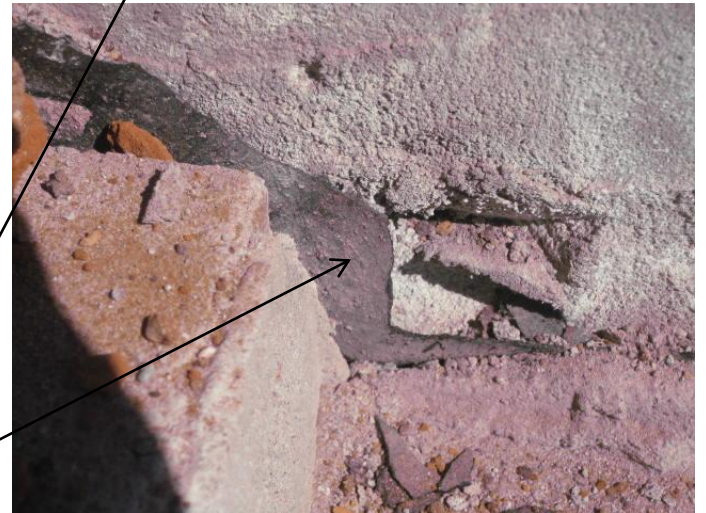
Asbestos materials discovered during demolition (north
and west walls)

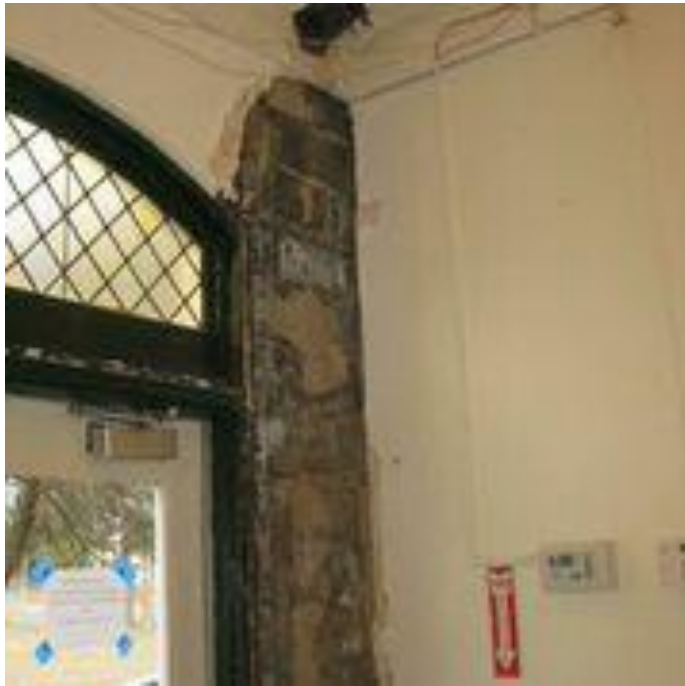
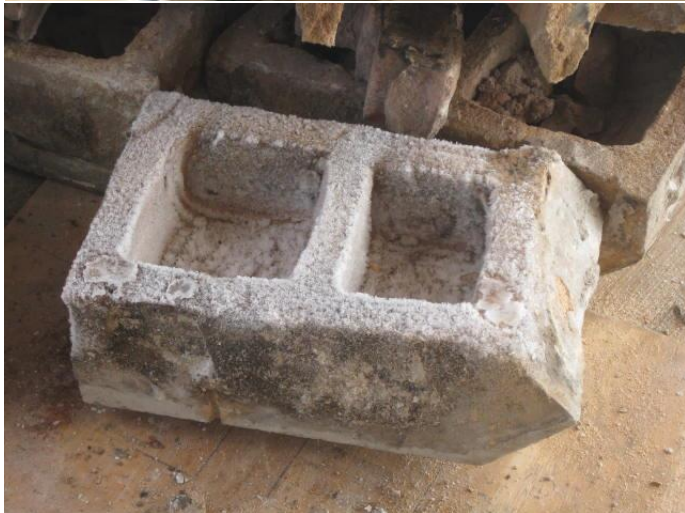
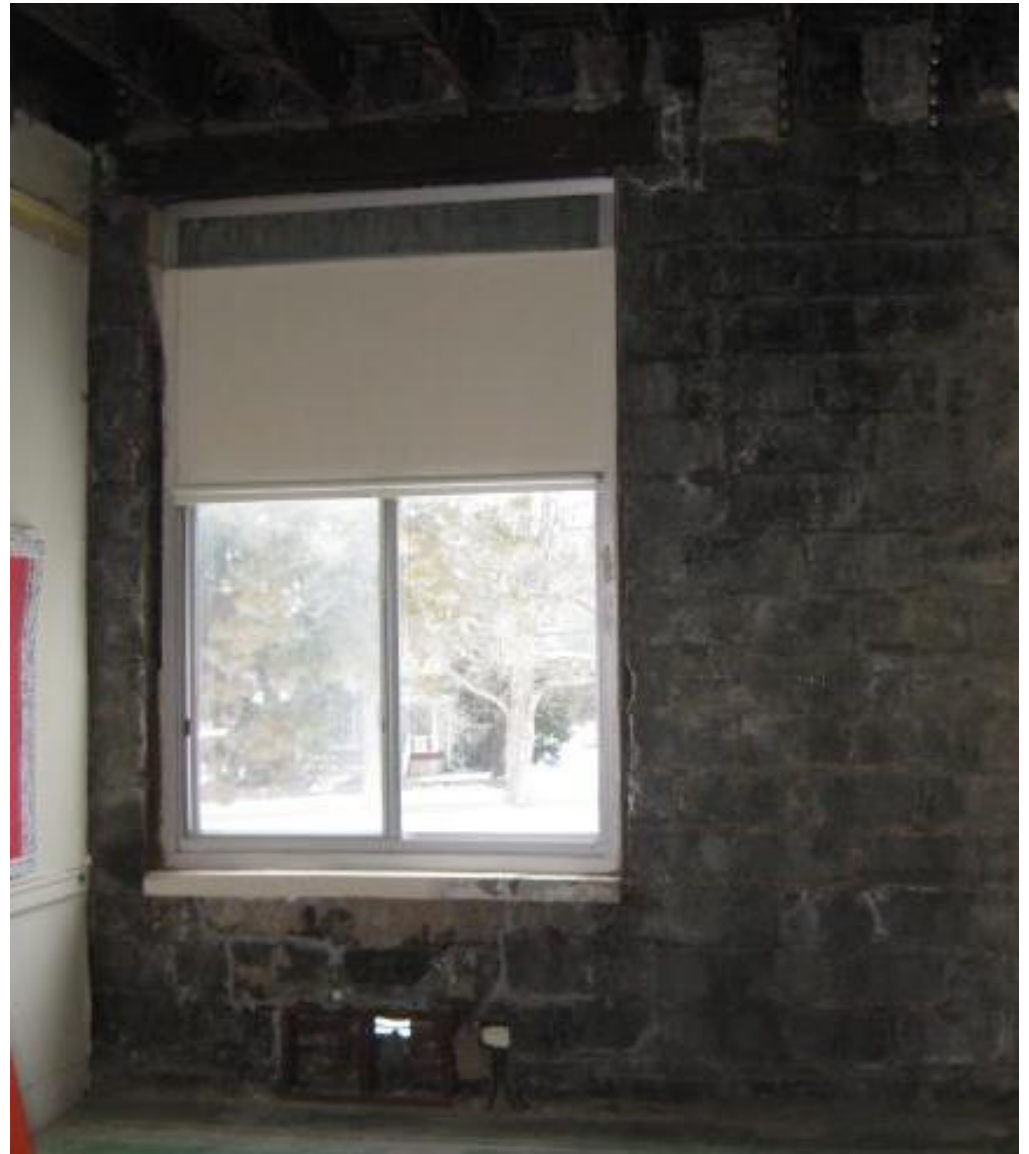
Water / Moisture evidence within north (front) wall.

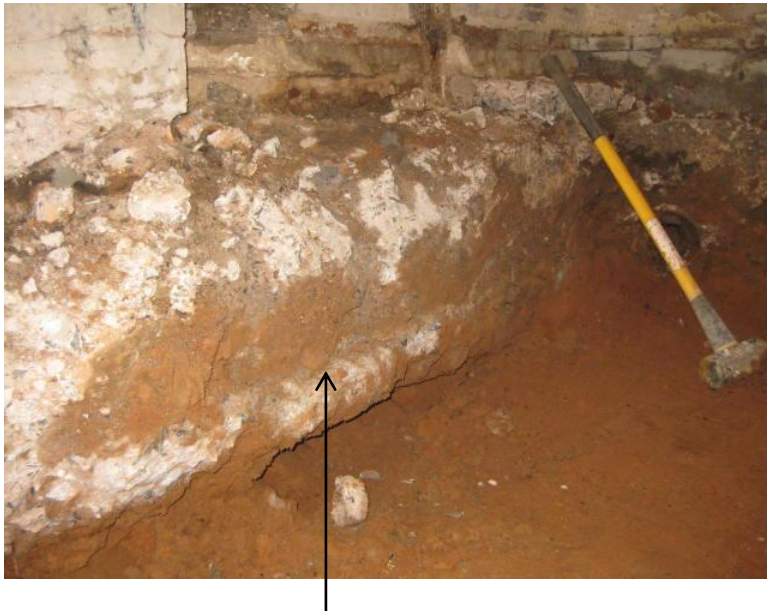
South wall foundation constructed only 24 inches below grade. (should be 4 feet)

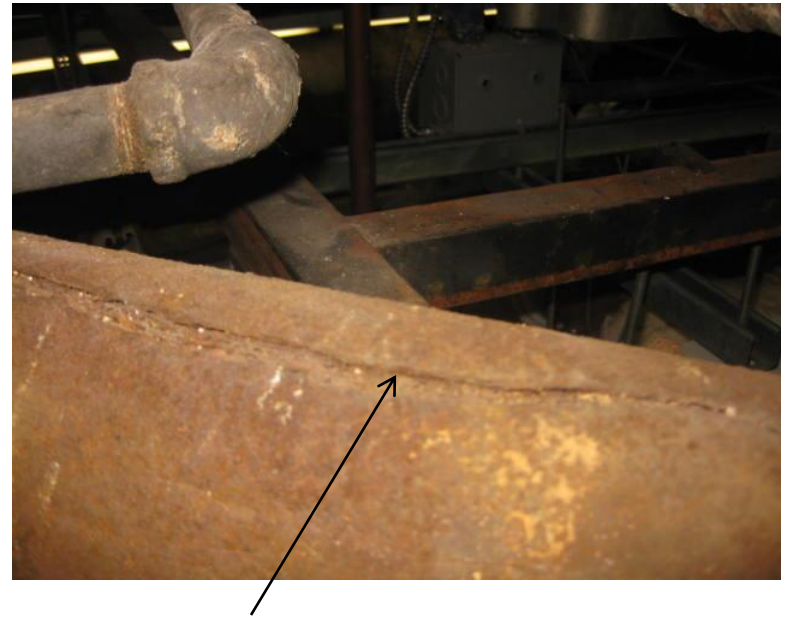
Full longitudinal crack in sanitary waste line.

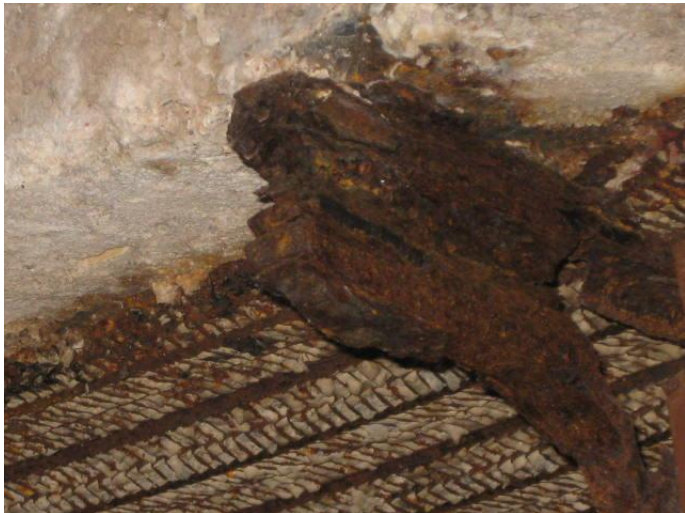
End of roof joist corroded at north wall.

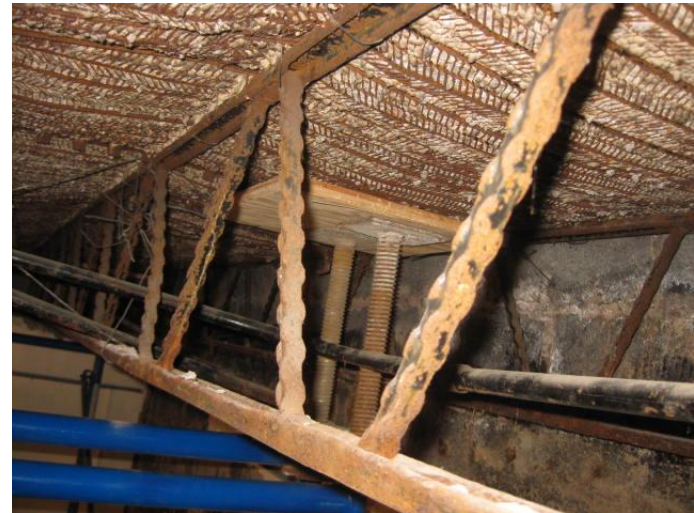
Corrosion of roof joist and deck.
