ROOF EVALUATIONS

Clarkstown Central
School District

June 2015

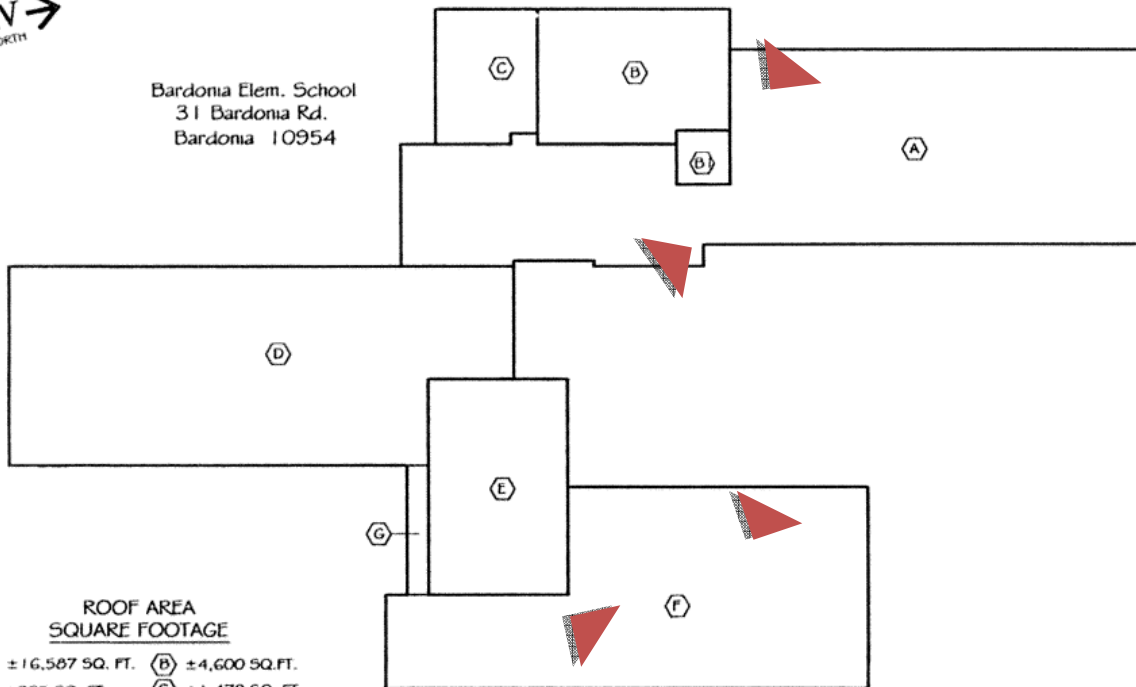
Bardonia Elem. School
31 Bardonia Rd.
Bardonia 10954

- A. Original Vintage- Poor Condition (≈30 year old system).
- B. Addition- Good Condition (≈15 year old system).
- C. Small projections covered in EPDM (≈30 year old system).
- D. (1) Stepped condition above lower roof.
- E. Existing curb reveal requires additional investigation, newer curb penetrations are acceptable.

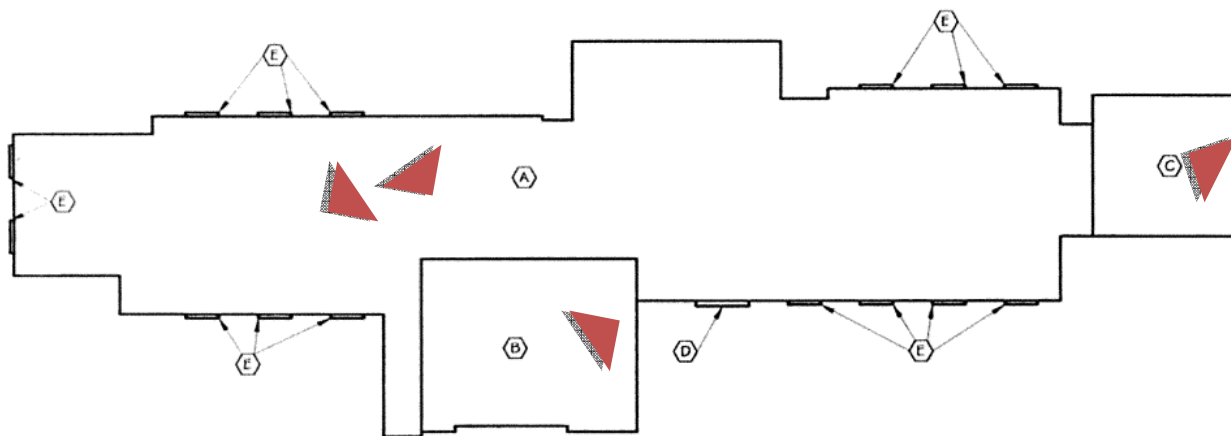
Lakewood Elk School
77 Lakeland Ave.
Congers 10920

- A. Original Vintage- Poor Condition (≈30 year old system).
- B. Addition- Good Condition (≈11 year old system).
- C. Exposed sanitary vent lines
- D. (1) Stepped condition above lower roof.
- E. Existing curb reveal requires additional investigation, newer curb penetrations, are acceptable.

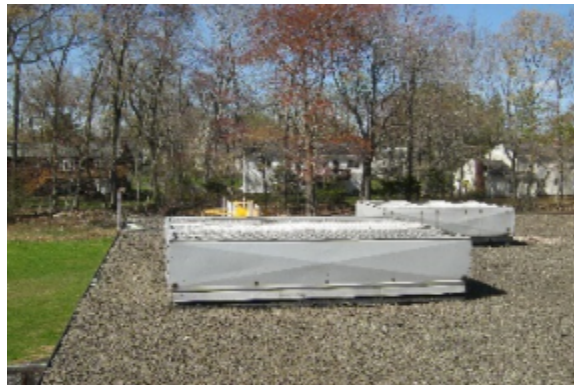
- A. Original Vintage- Poor Condition (≈30 year old system).
- B. (1) Stepped condition above lower roof.
- C. Existing curb reveal is insufficient for adequate flashing as directed by current manufacturer's standards.

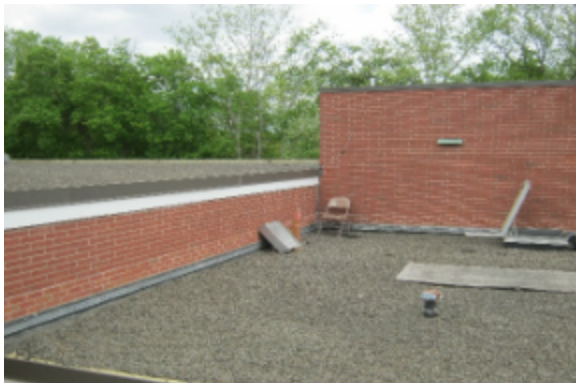
- A. Original Vintage- Poor Condition (≈30 year old system).
- B. Addition- Good Condition (≈11 year old system).
- C. (1) Stepped condition above lower roof.
- D. Exposed gas piping.
- E. Existing curb reveal requires additional investigation, newer curb penetrations, within IRMA system are acceptable.

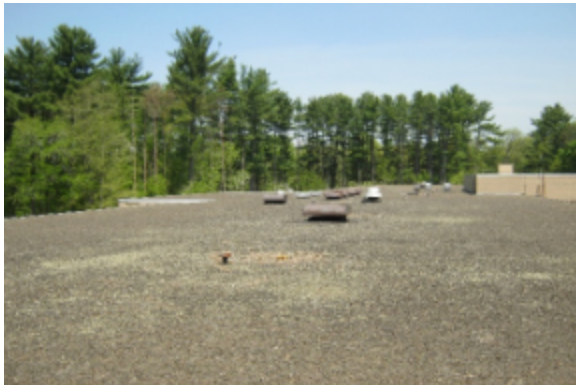
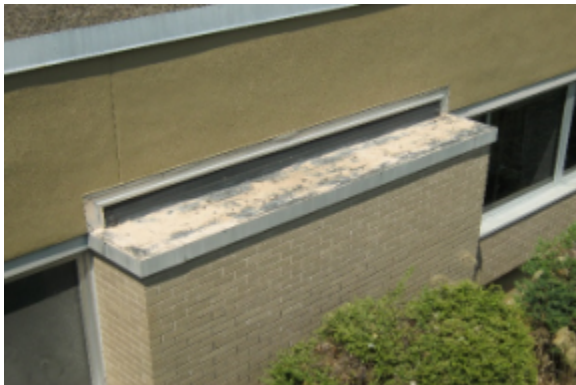
- A. Original Vintage- Poor Condition (≈30 year old system).
- B. Elevator Addition- Good Condition (≈10 year old system).
- C. Small projections covered in EPDM (Age Unknown).
- D. (1) Stepped condition above lower roof.
- E. Existing curb reveal requires additional investigation, newer curb penetrations are acceptable.

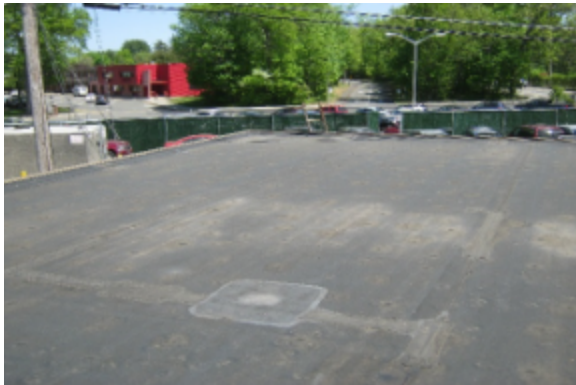
- A. Original Vintage (Partial)-Fair Condition (Age Unknown).
- B. (1) Stepped condition above lower roof.

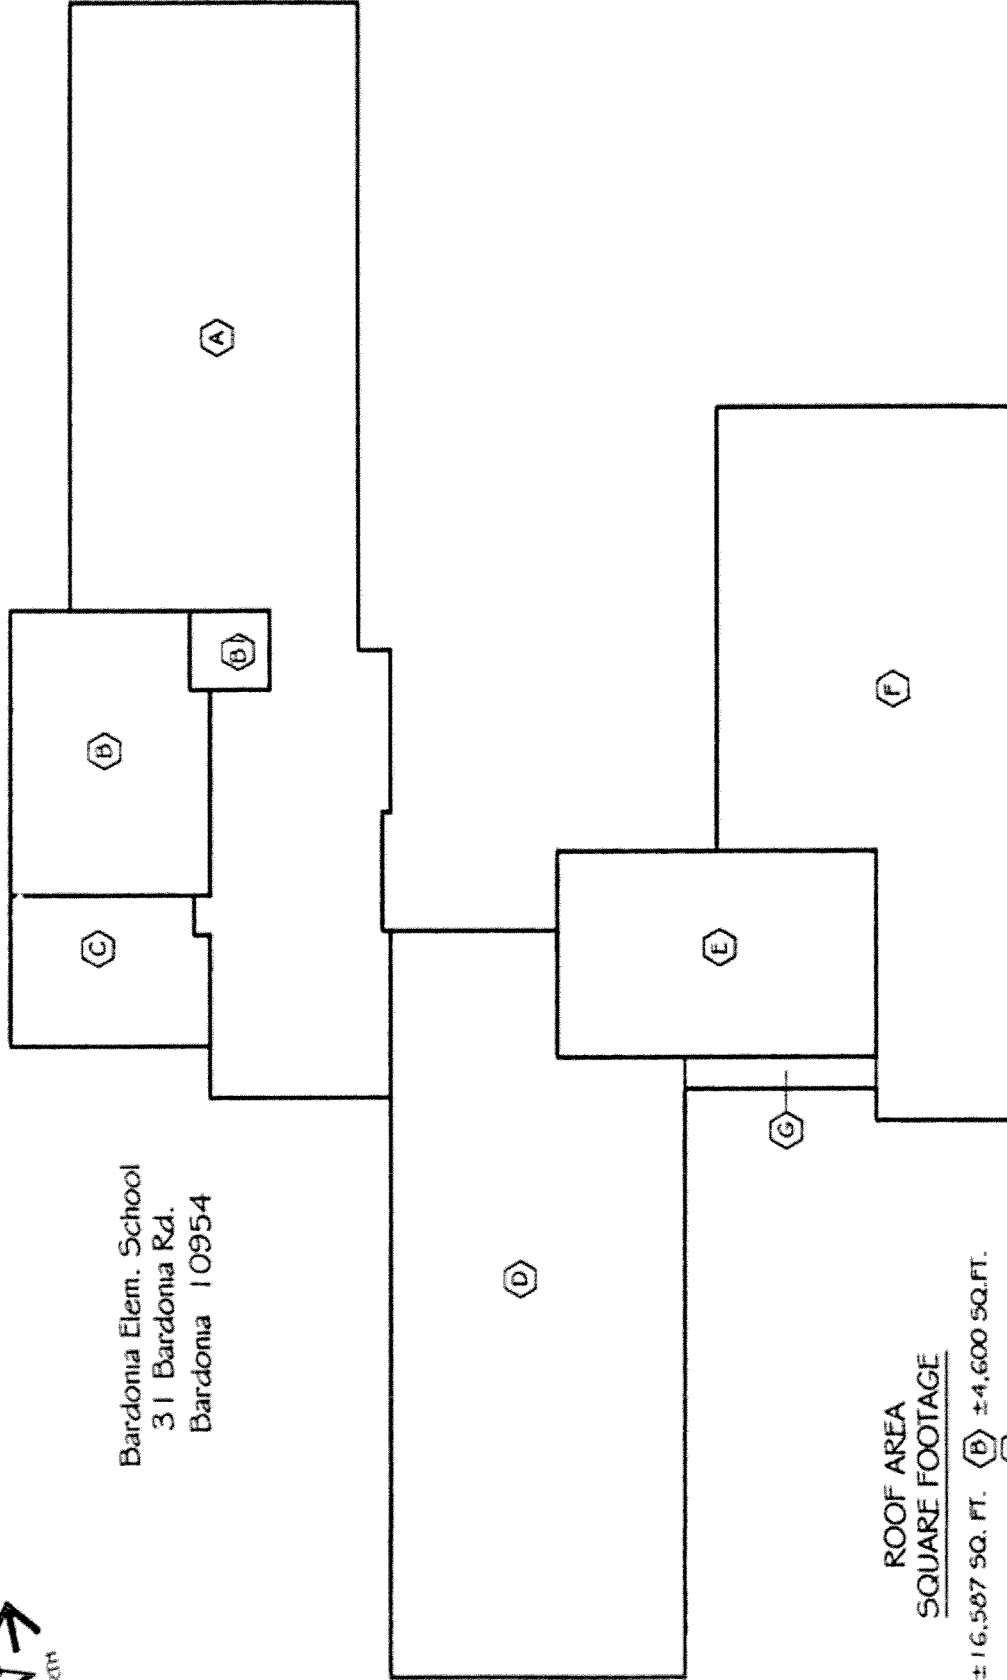
Bardonia Elem. School
31 Bardonia Rd.
Bardonia 10954

Roof Area	Square Footage	Membrane System Type	Year Installed	Current Condition
A	4,038	Built-up Roof	2005	Good
B	4,038	Built-up Roof	2005	Good
C	1,190	Built-up Roof	2005	Good
D	1,121	Built-up Roof	2005	Good
E	6,455	Single ply	2005	Good
F	2,510	Built-up Roof	2005	Good
G	4,260	EPDM adhered	2005	Good
Total	32,514

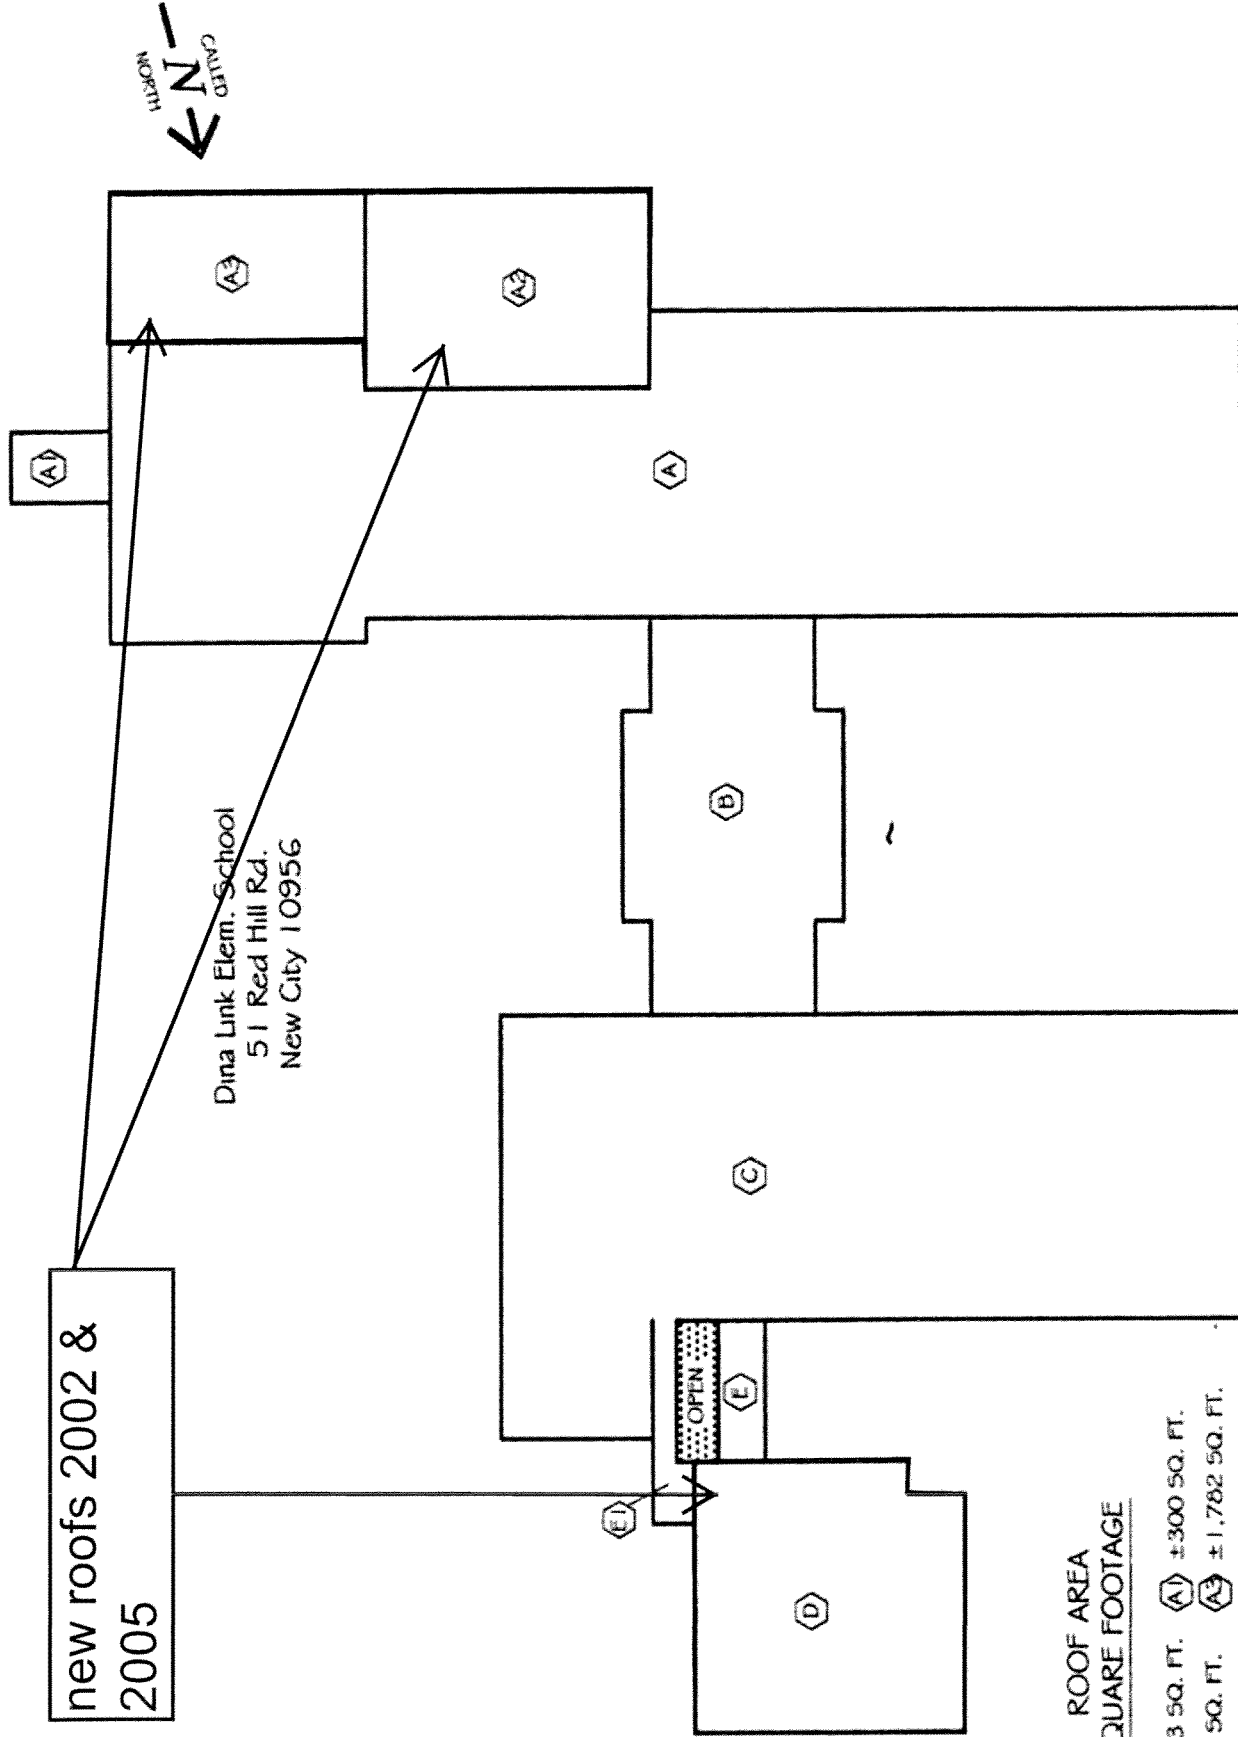
Roof Area	Square Footage	Membrane System Type	Year Installed	Current Condition
A	14,403	EPDM IRMA	1985	Poor
A1	300	EPDM adhered	2005	Good
A2	2,565	EPDM IRMA	1985	Poor
A3	1,782	EPDM adhered	2005	Good
B	3,515	EPDM IRMA	1985	Poor
C	11,272	EPDM IRMA	1985	Poor
D	3,165	EPDM adhered	2004	Good
E	300	EPDM adhered	2004	Good
Total	37,302

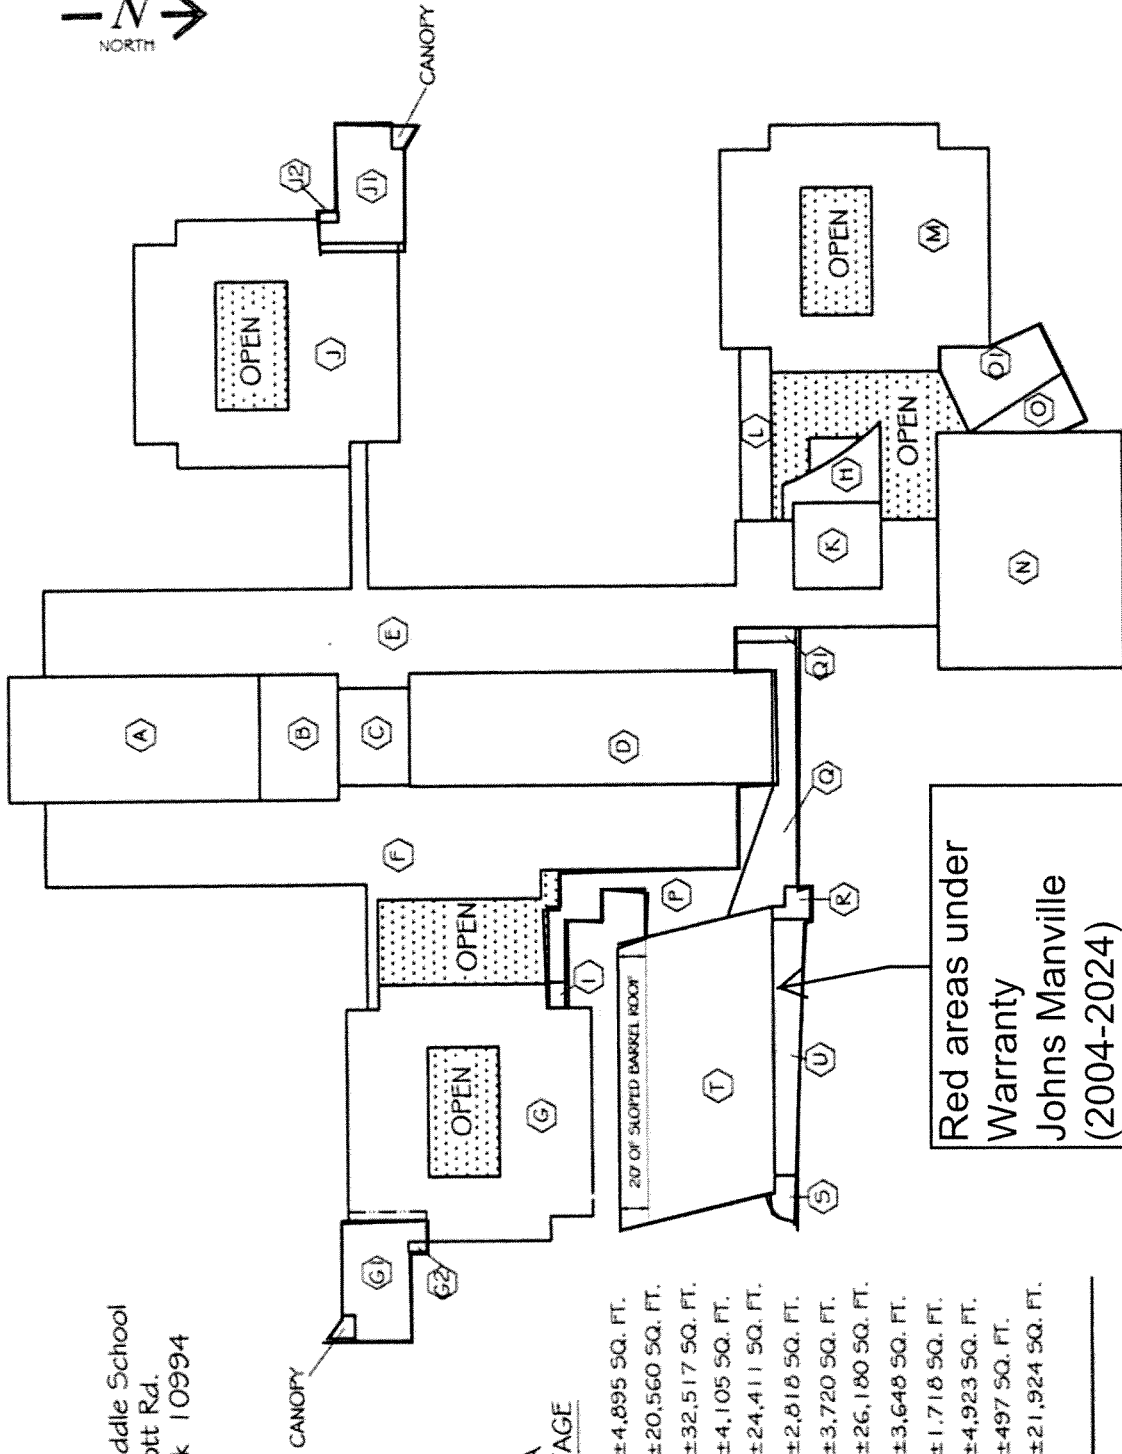
Felix Festa Middle School
30 Parrott Rd.
West Nyack 10994

Roof Area	Square Footage	Membrane System Type	Year Installed	Current Condition
A	15,575	EPDM adhered	1984	Poor
B	4895	EPDM adhered	1984	Fair
C	3,450	Reinforced EPDM	1984	Fair to Poor
D	20,560	EPDM IRMA	1984	Poor
E	38,693	EPDM IRMA	1984	Poor
F	32,517	EPDM IRMA	1984	Poor
G	24,411	Built-up IRMA	1984	Fair
G1	4,105	EPDM adhered	2005	Good
H	2,818	EPDM adhered	Unknown	Good
I	252	EPDM adhered	2004	Good
J	25,140	Built-up IRMA	1984	Poor
J1	4,106	EPDM adhered	2004	Good
J2	91	EPDM adhered	2004	Good
K	3,720	EPDM adhered	Unknown	Poor
L	2,640	EPDM IRMA	Unknown	Fair
M	26,180	EPDM IRMA	1984	Poor
N	21,450	EPDM IRMA	1984	Poor
O	3,648	EPDM adhered	Unknown	Good
O1	1,718	EPDM adhered	2004	Good
P	5,730	EPDM adhered	2004	Good
Q	4,923	EPDM adhered	2005	Good
Q1	420	EPDM adhered	2005	Good
R	497	EPDM adhered	2005	Good
S	426	EPDM adhered	2005	Good
T	21,924	EPDM adhered	2005	Good
U	3,602	EPDM adhered	2005	Good
Total	273,491

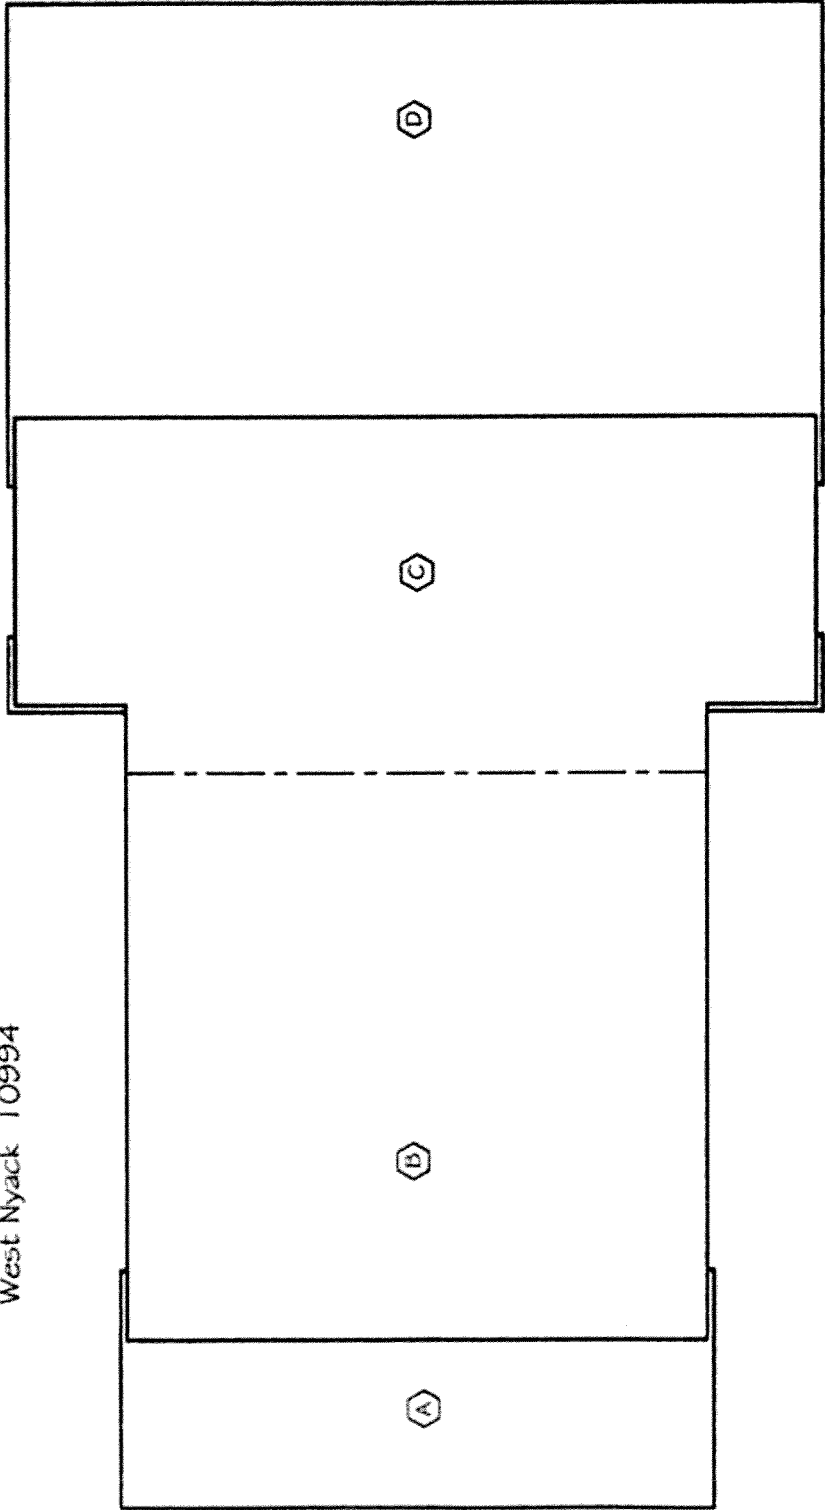
Felix Festa Middle School
Transportation Building
30 Parrott rd.
West Nyack 10994

Roof Area	Square Footage	Membrane System Type	Year Installed	Current Condition
A	766	EPDM IRMA	1984	Fair
B	1,260	EPDM IRMA	1984	Fair
C	1,430	EPDM adhered	Unknown	Fair
D	2,100	EPDM adhered	Unknown	Fair
Total	6,056

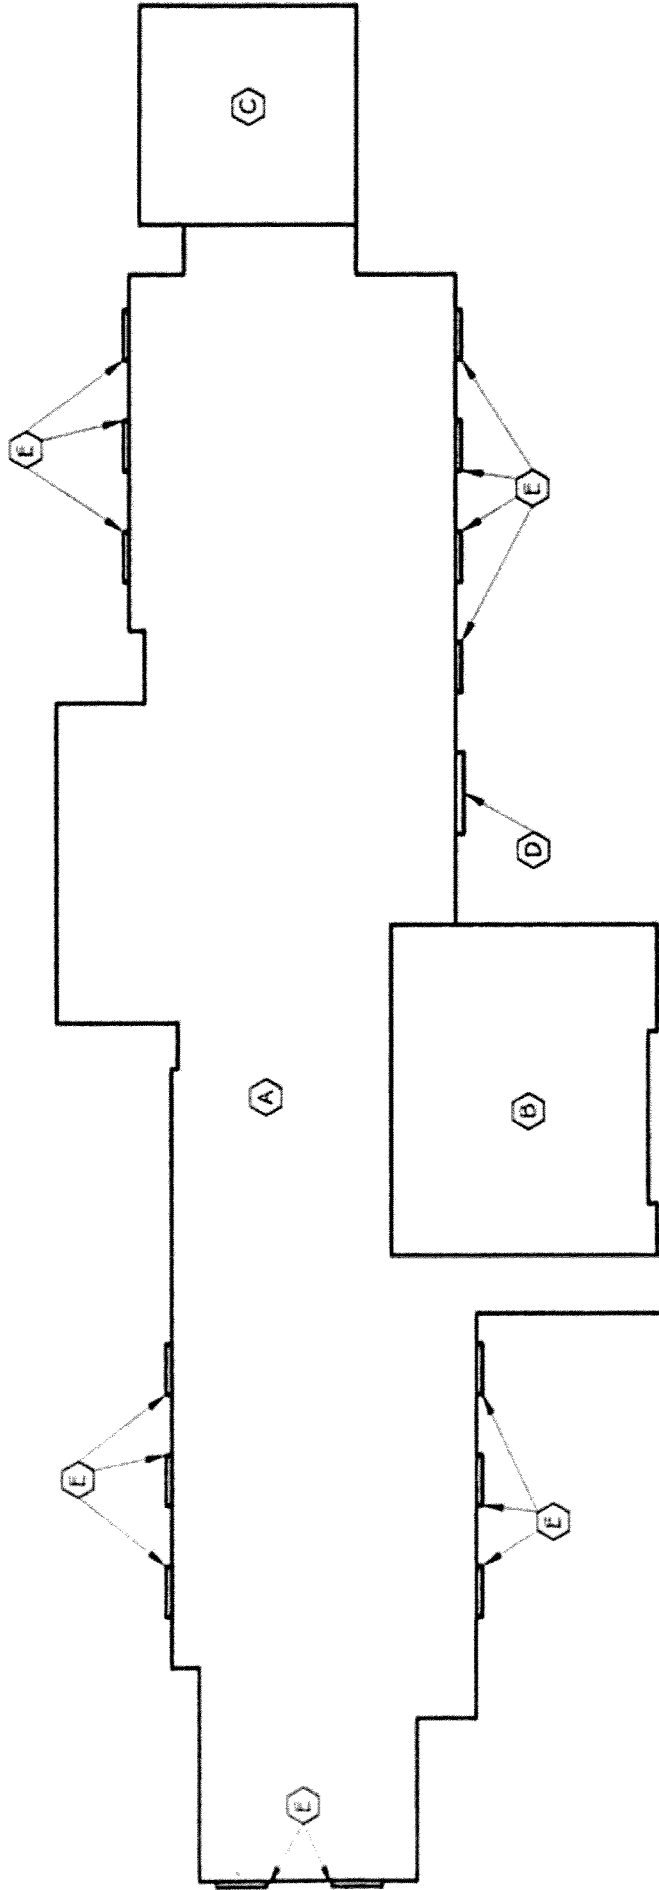
Lakewood Elk School
77 Lakeland Ave.
Congers 10920

Roof Area	Square Footage	Membrane System Type	Year Installed	Current Condition
A	25,930	EPDM IRMA	1985	Fair to poor
B	4,596	EPDM IRMA	1985	Fair to poor
C	2,500	EPDM adhered	2000	Good
D	34	EPDM adhered	1985	Fair to poor
E	225	EPDM adhered	1985	Fair to poor
Total	33,285

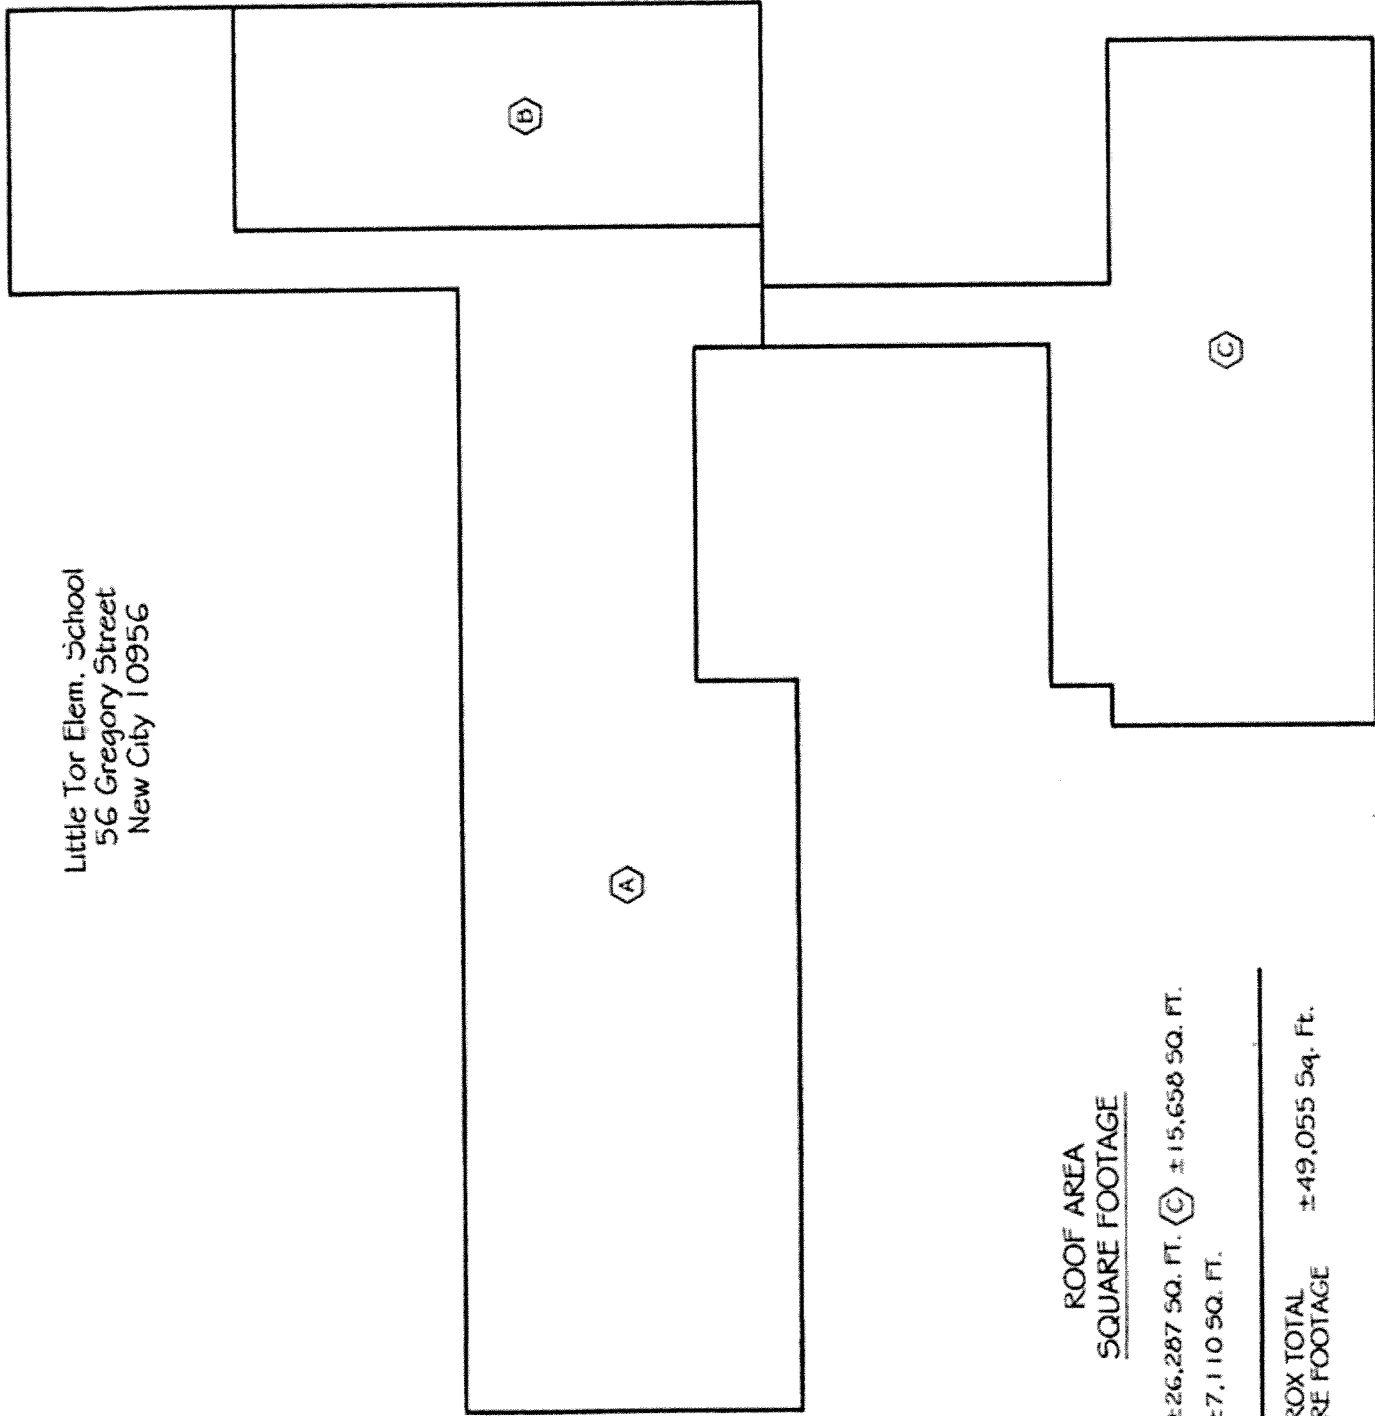
Little Tor Elem. School
56 Gregory Street
New City 10956

Roof Area	Square Footage	Membrane System Type	Year Installed	Current Condition
A	26,287	EPDM IRMA	1986	Poor
B	7,110	EPDM IRMA	1986	Poor
C	15,658	EPDM IRMA	1986	Poor
Total	49,055

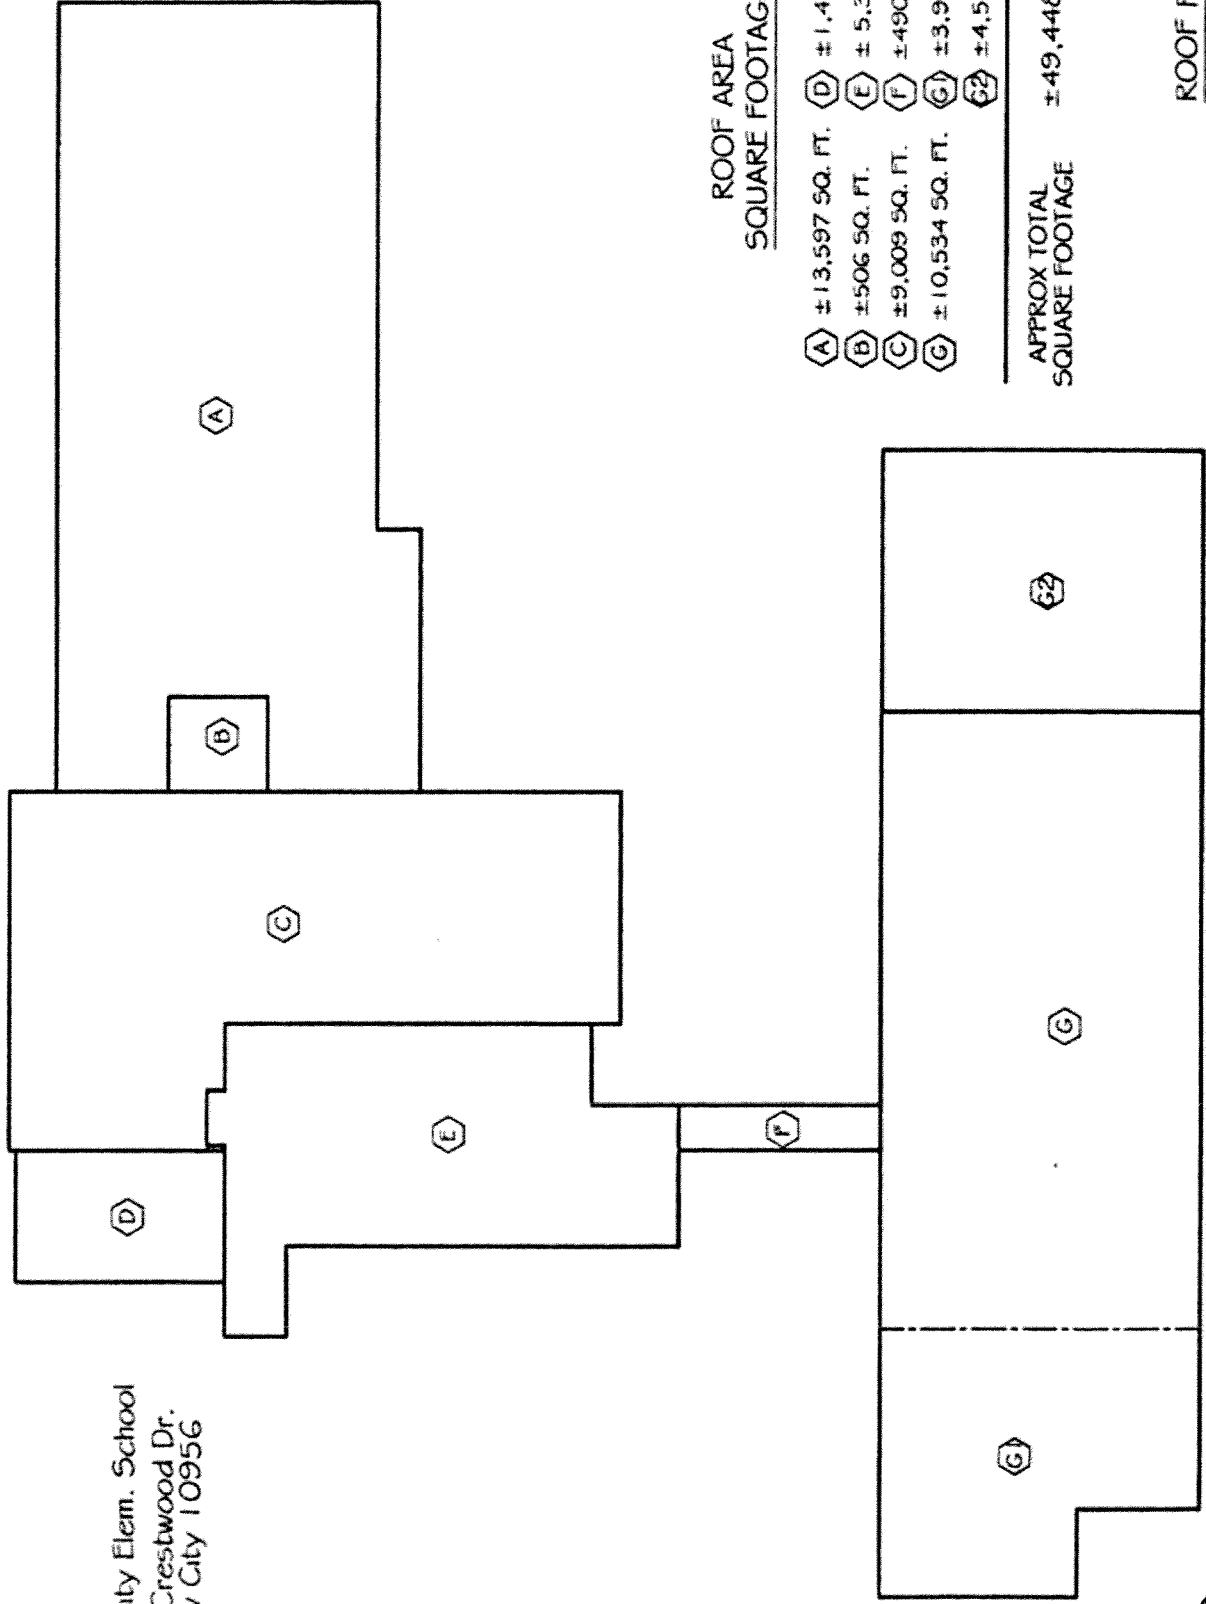
New City Elem. School
 60 Crestwood Dr.
 New City 10956

Roof Area	Square Footage	Membrane System Type	Year Installed	Current Condition
A	13,597	EPDM IRMA	1984	Poor
B	506	EPDM IRMA	1984	Poor
C	9,009	EPDM IRMA	1984	Poor
D	1,456	EPDM IRMA	1984	Poor
E	5,390	EPDM IRMA	1984	Poor
F	490	EPDM IRMA	1984	Poor
G	10,534	EPDM IRMA	1984	Poor
G1	3,952	EPDM IRMA	1984	Poor
G2	4,514	EPDM IRMA	1984	Poor
Total	49,448

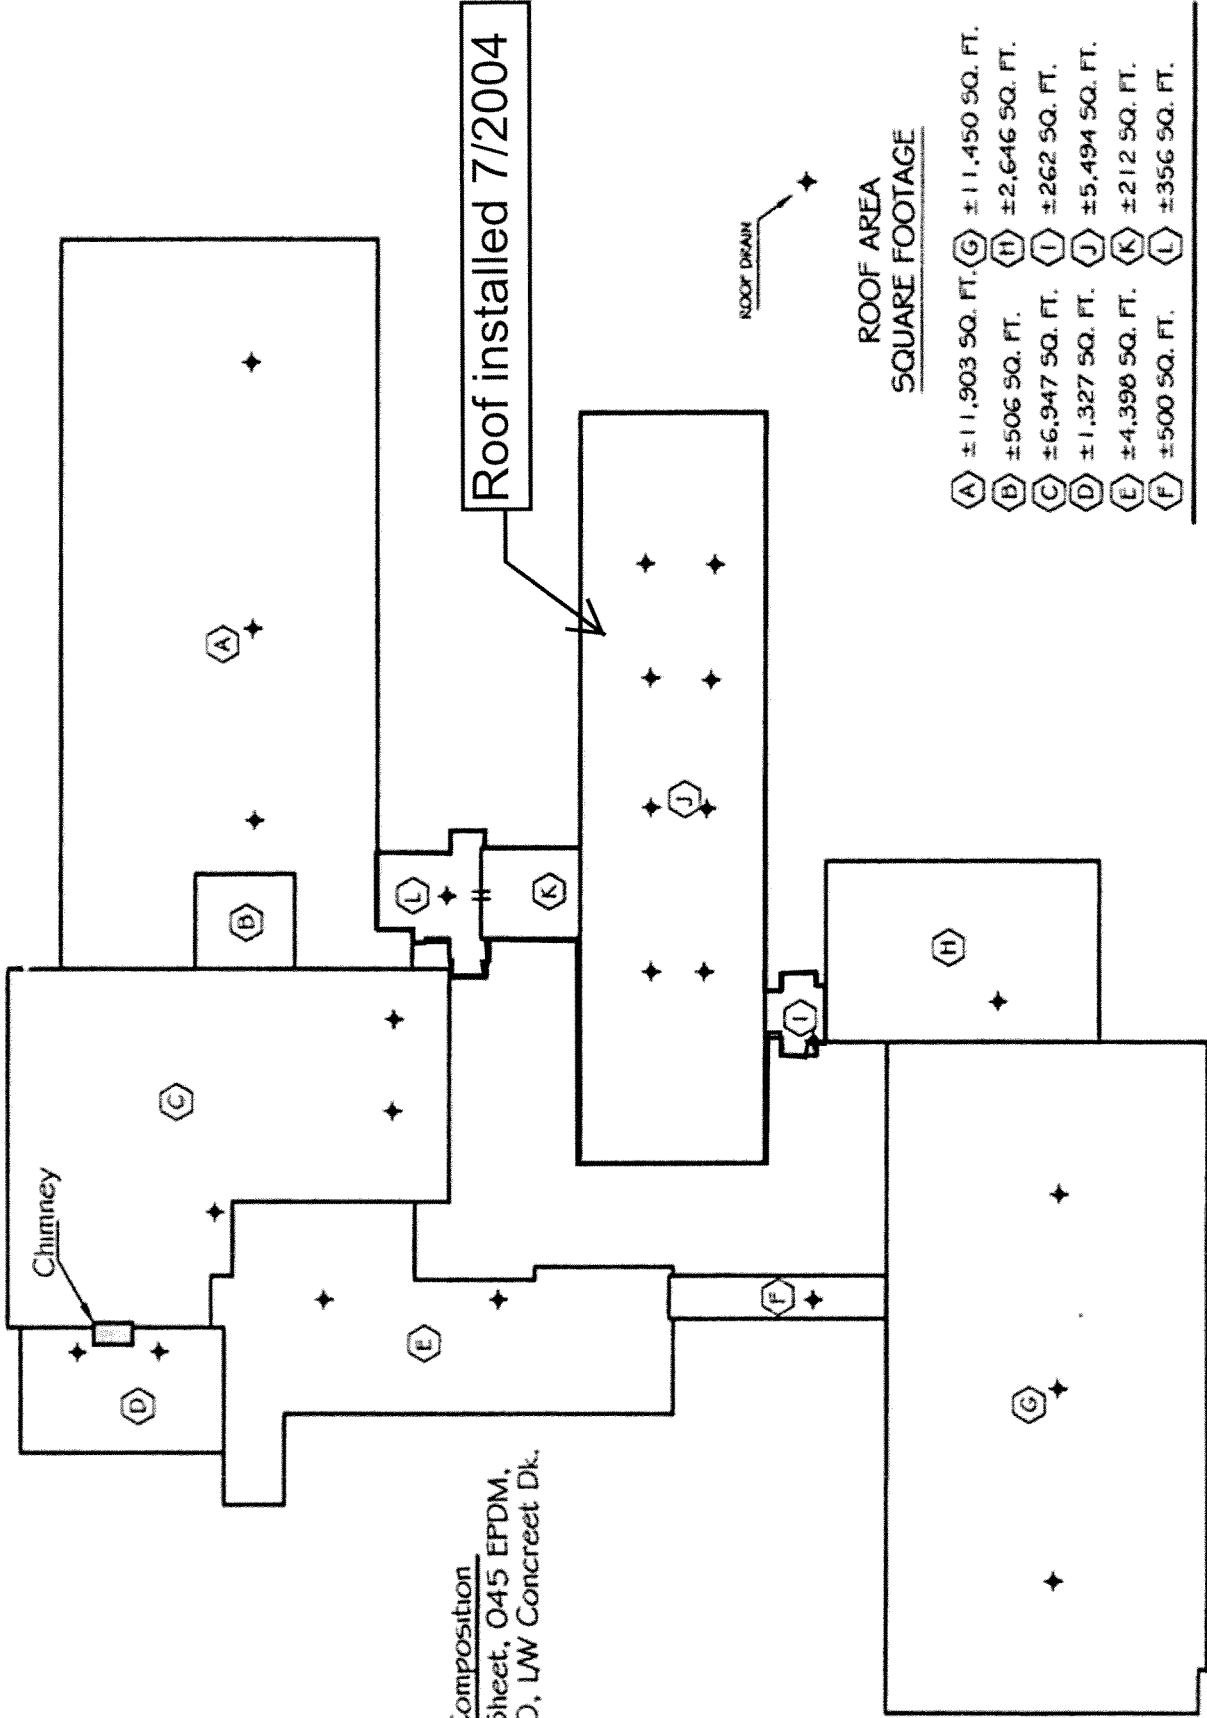
West Nyack El. School
 661 W Nyack Rd.
 West Nyack 10994

Roof Area	Square Footage	Membrane System Type	Year Installed	Current Condition
A	12,740	EPDM IRMA	1985	Poor
B	400	EPDM IRMA	1985	Poor
C	6,785	EPDM IRMA	1985	Poor
D	1,950	EPDM IRMA	1985	Degraded
E	5,285	EPDM IRMA	1985	Degraded
F	900	EPDM IRMA	1985	Poor
G	11,200	EPDM IRMA	1985	Poor
H	2,700	EPDM IRMA	1985	Poor
I	262	EPDM adhered	2004	Good
J	5,494	EPDM adhered	2004	Good
K	212	EPDM adhered	2004	Good
L	356	EPDM adhered	2004	Good
Total	48,284
